## Access Compliance Report Public Rights-of-Way (Curb Ramps)

Intersection ID: 3658Main Street:DAVIS\_LAKE\_PYCross Street:HARRIS\_GLEN\_DRLocation:WADA ID: CE0F5991B49DRamp Type:PerpInitial Pass/Fail:FailOverall Compliance:NoSeverity Score:10

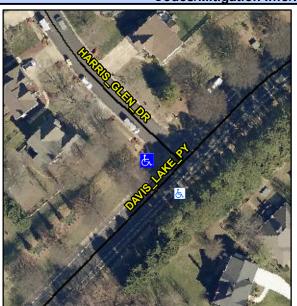
Not Found, R304.5.1, R304.5.3

Field Measurements/Component Compliance						
	Compliance Description		Data	Compliance Description		Data
	N/A	Ramp Length (in)	51.0	Yes	Ramp Slope (%)	6.0
	No	Ramp Width (in)	38.0	No	Ramp XSlope (%)	3.7
	N/A	Flare Type LT	N/A	N/A	Flare Type RT	N/A
	N/A	Flare Slope LT (%)	N/A	N/A	Flare Slope RT (%)	N/A
	N/A	Flare Traversable LT?	N/A	N/A	Flare Traversable RT?	N/A
	N/A	Landing Length (in)	N/A	N/A	DWS Provided?	N/A
	N/A	Landing Width (in)	N/A	N/A	DWS Contrast?	N/A
	N/A	Landing Slope (%)	N/A	N/A	DWS Length (in)	N/A
	N/A	Landing X Slope (%)	N/A	N/A	DWS Full Width?	N/A
	N/A	Landing Curb? (Y/N)	N/A	N/A	DWS Offset (in)	N/A
	N/A	Shared Landing?	N/A			
	N/A	Gutter Ponding?	N/A	N/A	Gutter Slope (%)	N/A
	N/A	Gutter Lip Ht (in)	N/A	N/A	Gutter X Slope (%)	N/A
	N/A	Painted X Walk1?	No	N/A	Painted X Walk2?	N/A
		X Walk 1 Direction	To SE		X Walk 2 Direction	N/A
	N/A	X Walk 1 Width (in)	N/A	N/A	X Walk 2 Width (in)	N/A
		X Walk 1 Slope (%)	0.9		X Walk 2 Slope (%)	N/A

X Walk 1 X Slope (%)	2.2		X Walk 2 X Slope (%)	N/A
	N/A	Ramp inside XWalk1?	N/A	N/A	Ramp inside XWalk2?	N/A
		Road Slope (%)	N/A	N/A	Clear Space?	N/A
		Road X Slope (%)	N/A	N/A	Clear Space to XWalk (in)	N/A
	N/A	Any Obstructions?	N/A	N/A	Storm Grate/Utility Hazard?	N/A
		Obstruction Type			Storm Grate/Utility Type	
			N/A			N/A
				Yes	Surface Condition? (G/P)	Good

Remove & Replace Entire Ramp.
