Access Compliance Report

Public Rights-of-Way

(Curb Ramps)

Intersection ID: 49791	Main Street: BAHIA_LN	Cross Street: BARLEY_LN	Location: S
ADA ID: CE6567974449	Ramp Type: Perp	Initial Pass/Fail: Fail	Overall Compliance: No
Severity Score: 8.75			
Codes/Mitigation Info/Possible Solution		Field Measurements/Component Compliance

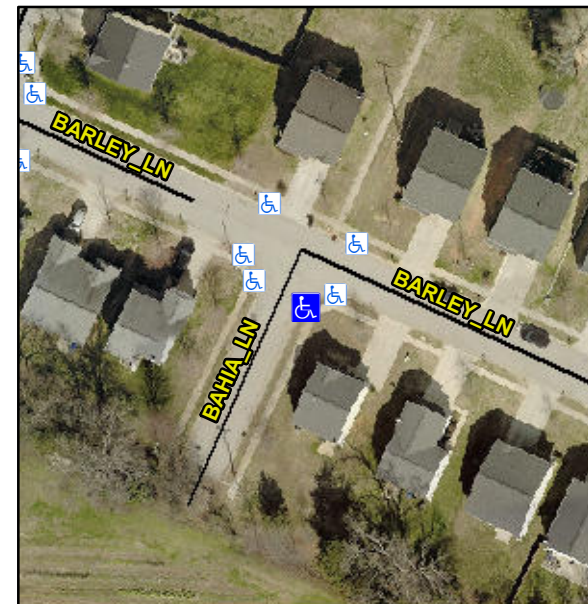
Not Found, R304.5.1

Remove & Replace Entire Ramp.
