Access Compliance Report Public Rights-of-Way (Curb Ramps)

Intersection ID: 18809 Main Street: CEDARBARK_DR Cross Street: ROSEDOWN_DR Location: SE

ADA ID: CE8CB2B2C229 Ramp Type: PerpDiag Initial Pass/Fail: Fail Overall Compliance: No Severity Score: 46.25

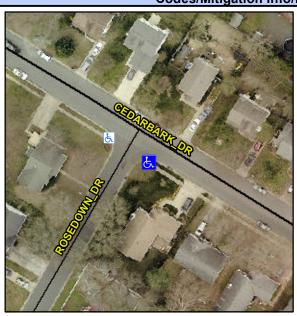
Not Found, R304.5.1, R304.2.2, R304.5.3

Field Measurements/Component Compliance					
Compliance Description		Data	Compliance Description		Data
N/A	Ramp Length (in)	47.0	No	Ramp Slope (%)	13.3
No	Ramp Width (in)	47.5	No	Ramp XSlope (%)	6.5
N/A	Flare Type LT	N/A	N/A	Flare Type RT	N/A
N/A	Flare Slope LT (%)	N/A	N/A	Flare Slope RT (%)	N/A
N/A	Flare Traversable LT?	N/A	N/A	Flare Traversable RT?	N/A
N/A	Landing Length (in)	N/A	N/A	DWS Provided?	N/A
N/A	Landing Width (in)	N/A	N/A	DWS Contrast?	N/A
N/A	Landing Slope (%)	N/A	N/A	DWS Length (in)	N/A
N/A	Landing X Slope (%)	N/A	N/A	DWS Full Width?	N/A
N/A	Landing Curb? (Y/N)	N/A	N/A	DWS Offset (in)	N/A
N/A	Shared Landing?	N/A			
N/A	Gutter Ponding?	N/A	N/A	Gutter Slope (%)	N/A
N/A	Gutter Lip Ht (in)	N/A	N/A	Gutter X Slope (%)	N/A
N/A	Painted X Walk1?	No	N/A	Painted X Walk2?	No
	X Walk 1 Direction	To NE		X Walk 2 Direction	To NW
N/A	X Walk 1 Width (in)	N/A	N/A	X Walk 2 Width (in)	N/A
	X Walk 1 Slope (%)	4.9		X Walk 2 Slope (%)	5.6

X Walk 1 X Slope (%)	7.6		X Walk 2 X Slope (%)	2.1
N/A	Ramp inside XWalk1?	N/A	N/A	Ramp inside XWalk2?	N/A
	Road Slope (%)	5.8	N/A	Clear Space?	N/A
	Road X Slope (%)	2.9	N/A	Clear Space to XWalk (in)	N/A
N/A	Any Obstructions?	N/A	N/A	Storm Grate/Utility Hazard?	N/A
	Obstruction Type		l	Storm Grate/Utility Type	
		N/A			N/A
			Yes	Surface Condition? (G/P)	Good

Remove & Replace Curb Ramp With Two New Directional Ramps or Equivalent.
