# Access Compliance Report

## Public Rights-of-Way

### (Curb Ramps)

| Intersection ID: 13889 | Main Street: DENVIEW_LN | Cross Street: KENHILL_DR | Location: SW |

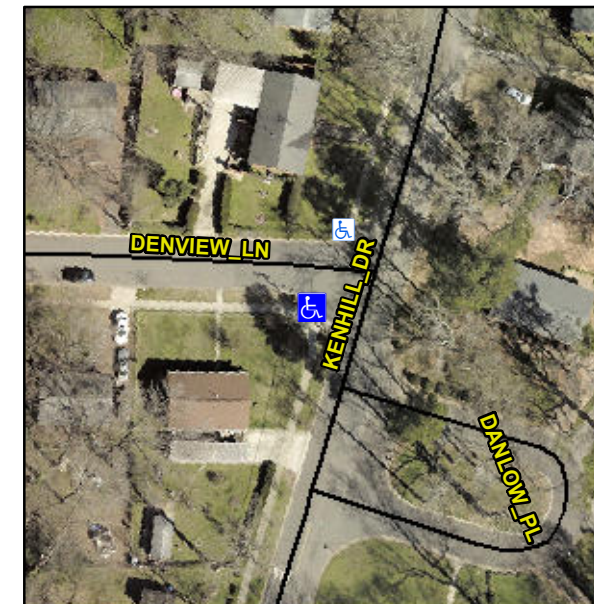
| ADA ID: CE9BC0A1675D | Ramp Type: PerpDiag | Initial Pass/Fail: Fail | Overall Compliance: No |

| Compliance | Description | Data | Compliance | Description | Data |
|---|---|---|---|---|---|
| N/A | Ramp Length (in) | 74.0 | No | Ramp Slope (%) | 8.6 |
| No | Ramp Width (in) | 46.0 | Yes | Ramp XSlope (%) | 0.2 |

**Remove & Replace Curb Ramp With Two New Directional Ramps or Equivalent.**
