# Access Compliance Report

## Public Rights-of-Way

| Intersection ID: 50321 | Main Street: BELMAR_PLACE_RD | Cross Street: CINDY_LN | Location: SE |
| ADA ID: CEC3E2C90118 | Ramp Type: Directional1 | Initial Pass/Fail: Pass | Overall Compliance: No |

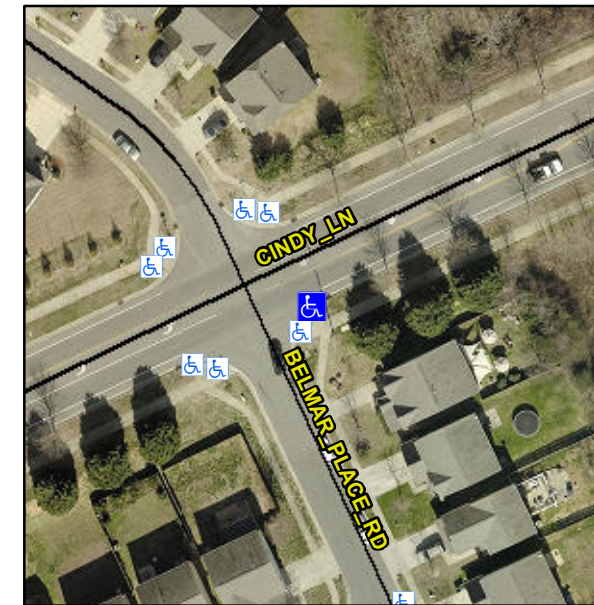
| | | | Severity Score: 2.5 |

**R304.5.3, R305.1.4, R305.2**

| Compliance | Description | Data | Compliance | Description | Data |
|---|---|---|---|---|---|
| Yes | Ramp Width (in) | 65.0 | No | Grade Break Slope (%) | 5.9 |
| Yes | Ramp Slope (%) | 7.5 | No | Grade Break XSlope (%) | 2.6 |
| Yes | Landing X Slope (%) | 1.7 | No | DWS Full Width? | No |
| N/A | Shared Landing? | Yes | No | DWS Offset RT (in) | 4.0 |
| Yes | Gutter Lip Ht (in) | 0.0 | No | Gutter X Slope (%) | 3.2 |

**Remove & Replace Entire Ramp.  
Remove & Replace Gutter.**
