Access Compliance Report Public Rights-of-Way (Curb Ramps)

| Intersection ID: 53380 | Main Street: IKEA_BV | Cross Street: LEWIS_ST | Location: N |
| ADA ID: CEFDC40789DF | Ramp Type: BlendTrans1 | Initial Pass/Fail: Pass | Overall Compliance: No |

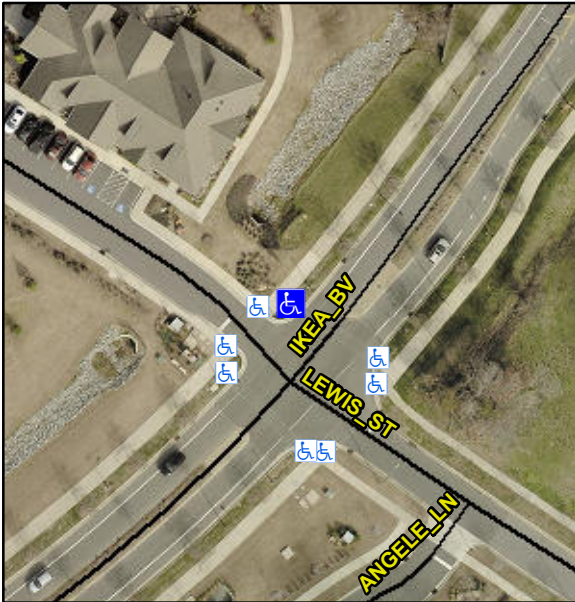
PROW/ADA:
Not Found, R302.7, R302.7.2, R304.5.3

| Compliance | Description | Data | Compliance | Description | Data |
|---|---|---|---|---|---|
| No | Gutter Ponding? | Yes | Yes | Gutter Slope (%) | 4.4 |
| No | Gutter Lip Ht (in) | 0.3 | No | Gutter X Slope (%) | 3.8 |
| | | | No | Curb Slope (%) | 14.5 |

Possible Solutions:
Remove & Replace Curb Slope and Extend Ramp. Remove & Replace Gutter.
