# Access Compliance Report

## Public Rights-of-Way

| Intersection ID: 15457 | Main Street: EAST_BV | Cross Street: LOMBARDY_CR | Location: W |
| ADA ID: CF133F1EC469 | Ramp Type: Perp | Initial Pass/Fail: Fail | Overall Compliance: No |

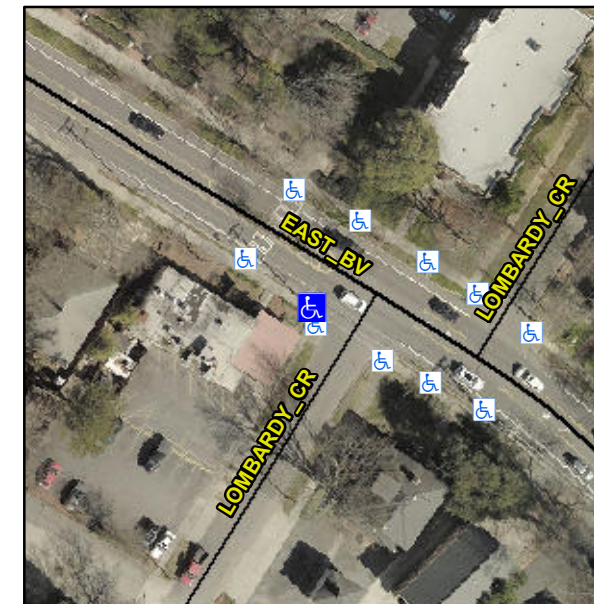
| | | Severity Score: 25 | |

**Not Found, R304.2.2, R304.5.3**

| Compliance | Description | Data | Compliance | Description | Data |
|---|---|---|---|---|---|
| N/A | Ramp Length (in) | 59.0 | No | Ramp Slope (%) | 10.3 |
| Yes | Ramp Width (in) | 48.0 | No | Ramp XSlope (%) | 6.3 |

**Remove & Replace Entire Ramp.**
