## Access Compliance Report Public Rights-of-Way (Curb Ramps)

Intersection ID: 13795Main Street:DENBUR\_DRCross Street:LUSTERLEAF\_HOLLY\_RDLocation:NEADA ID: CF5DB50F1E95Ramp Type:ParaInitial Pass/Fail:FailOverall Compliance:NoSeverity Score:26.25

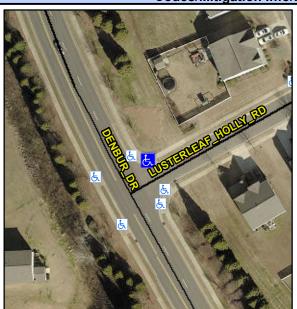
LT RP < 5%

R304.5.3, R304.3.2

Compliance Description Data Compliance Description Data					
N/A	Ramp Length LT (in)	52.5	N/A	Ramp Length RT (in)	42.0
Yes	Ramp Width LT (in)	59.5	Yes	Ramp Width RT (in)	60.5
Yes	Ramp Slope LT (%)	0.3	No	Ramp Slope RT (%)	12.2
No	Ramp XSlope LT (%)	2.4	No	Ramp XSlope RT (%)	4.2
N/A	Landing Length (in)	N/A	N/A	DWS Provided?	N/A
N/A	Landing Width (in)	N/A	N/A	DWS Contrast?	N/A
N/A	Landing Slope (%)	N/A	N/A	DWS Length (in)	N/A
N/A	Landing X Slope (%)	N/A	N/A	DWS Full Width?	N/A
N/A	Landing Curb? (Y/N)	N/A	N/A	DWS Offset (in)	N/A
N/A	Shared Landing?	N/A	IN/A	DWS Offset (III)	IN/A
N/A	Gutter Ponding?	N/A	N/A	Gutter Slope (%)	N/A
N/A	Gutter Lip Ht (in)	N/A	N/A	Gutter X Slope (%)	N/A
N/A	Painted X Walk1?	No.	N/A	Painted X Walk2?	N/A
IN/A	X Walk 1 Direction	To S	IN/A	X Walk 2 Direction	N/A N/A
N/A		N/A	N/A		N/A N/A
IN/A	X Walk 1 Slane (%)		IN/A	X Walk 2 Width (in)	
	X Walk 1 Slope (%)	5.0		X Walk 2 Slope (%)	N/A
NI/A	X Walk 1 X Slope (%)	3.8	NI/A	X Walk 2 X Slope (%)	N/A

Remove & Replace Entire Ramp.
