Access Compliance Report

Public Rights-of-Way

(Curb Ramps)

Intersection ID: 6956	Main Street: PLUMSTEAD_RD	Cross Street: MCALLISTER_DR	Location: SE
ADA ID: CF5FB558F27A	Ramp Type: Combination1	Initial Pass/Fail: Fail	Overall Compliance: No
		Severity Score: 50

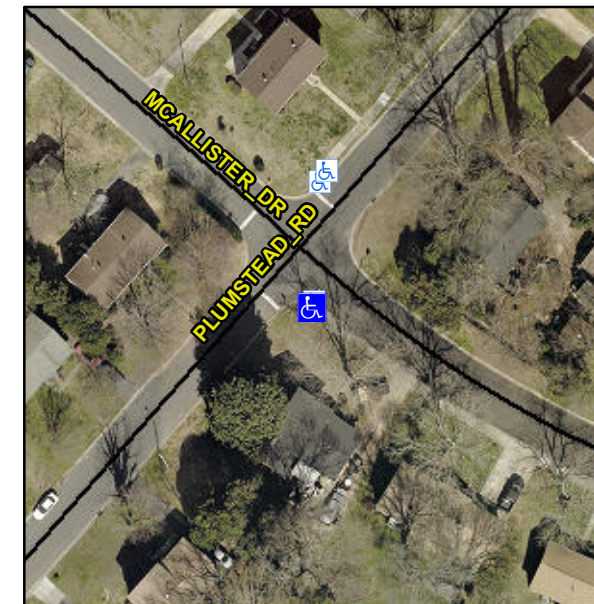
RP SL < 5%

Not Found, R304.5.3, R304.3.2

Remove & Replace Entire Ramp.
