Access Compliance Report Public Rights-of-Way (Curb Ramps)

Intersection ID: 11921 Main Street: COUNTRY CLUB DR **Cross Street: VENTOSA_DR** Location: **Overall Compliance: No ADA ID: CFCFBAF8421C** Ramp Type: Perp Initial Pass/Fail: Fail **Severity Score:** 22.5

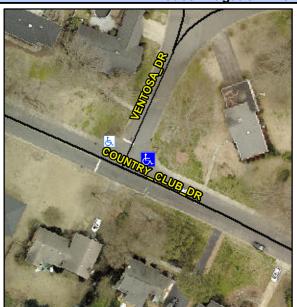
i cocibio colution	
Possible Solutions:	2
Remove & Replace Entire Ramp.	ı
	1
	ı
	ı
	ı
	ı
Surveyor Notes:	ı
N/A	ı
	ı
	ı
	ı
PROW/ADA:	ı
Not Found, R304.5.1, R304.2.2,	ı
R304.5.3	ı
	1

Field Measurements/Component Compliance							
Compliance Description		Data	Comp	liance Description	Data		
N/A	Ramp Length (in)	60.0	No	Ramp Slope (%)	11.4		
No	Ramp Width (in)	42.5	No	Ramp XSlope (%)	3.6		
N/A	Flare Type LT	N/A	N/A	Flare Type RT	N/A		
N/A	Flare Slope LT (%)	N/A	N/A	Flare Slope RT (%)	N/A		
N/A	Flare Traversable LT?	N/A	N/A	Flare Traversable RT?	N/A		
N/A	Landing Length (in)	N/A	N/A	DWS Provided?	N/A		
N/A	Landing Width (in)	N/A	N/A	DWS Contrast?	N/A		
N/A	Landing Slope (%)	N/A	N/A	DWS Length (in)	N/A		
N/A	Landing X Slope (%)	N/A	N/A	DWS Full Width?	N/A		
N/A	Landing Curb? (Y/N)	N/A	N/A	DWS Offset (in)	N/A		
N/A	Shared Landing?	N/A					
N/A	Gutter Ponding?	N/A	N/A	Gutter Slope (%)	N/A		
N/A	Gutter Lip Ht (in)	0.5	N/A	Gutter X Slope (%)	N/A		
N/A	Painted X Walk1?	No	N/A	Painted X Walk2?	N/A		
	X Walk 1 Direction	To NW		X Walk 2 Direction	N/A		
N/A	X Walk 1 Width (in)	N/A	N/A	X Walk 2 Width (in)	N/A

X Walk 1 Slope (%)	4.9		X Walk 2 Slope (%)	N/A		
	X Walk 1 X Slope (%)	0.9		X Walk 2 X Slope (%)	N/A		
N/A	Ramp inside XWalk1?	N/A	N/A	Ramp inside XWalk2?	N/A		
	Road Slope (%)	N/A	N/A	Clear Space?	N/A		
	Road X Slope (%)	N/A	N/A	Clear Space to XWalk (in)	N/A		
N/A	Any Obstructions?	N/A	N/A	Storm Grate/Utility Hazard?	N/A		
	Obstruction Type			Storm Grate/Utility Type			
		N/A			N/A		
			Yes	Surface Condition? (G/P)	Good		
3
