Access Compliance Report

Public Rights-of-Way

(Curb Ramps)

Intersection ID: 12655	Main Street: GOLF_ACRES_DR	Cross Street: MORRIS_FIELD_DR	Location: SW
ADA ID: CFF703D91462	Ramp Type: Combination1	Initial Pass/Fail: Fail	Overall Compliance: No
			Severity Score: 13.75

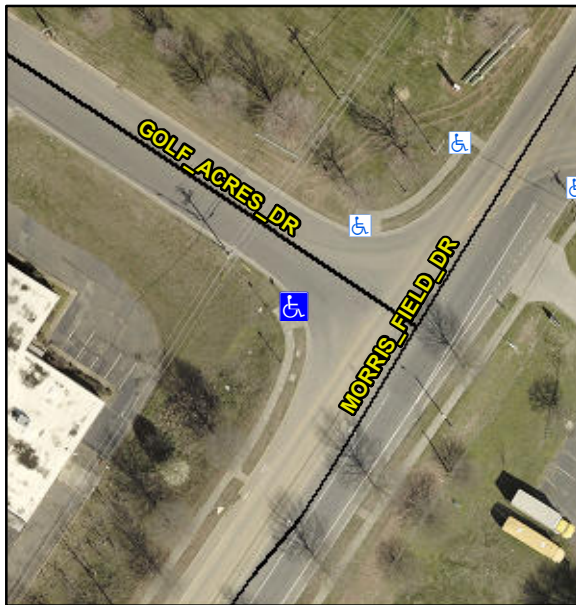
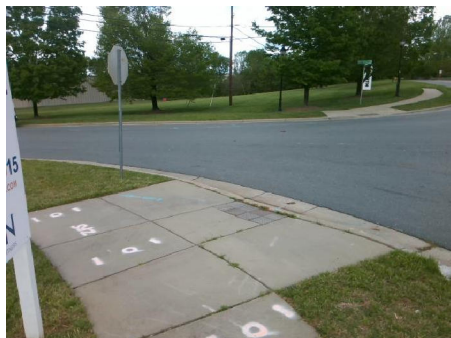
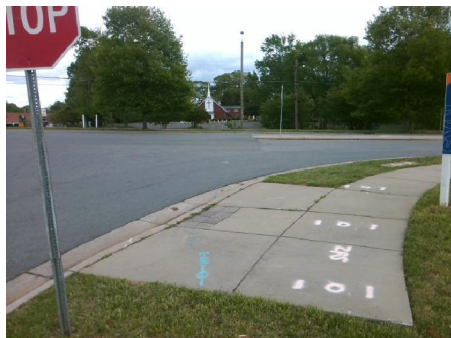
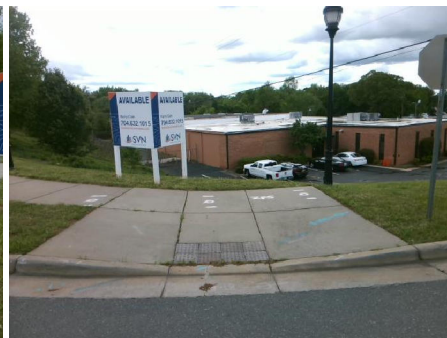
RT RP < 5%

Not Found, R304.5.3, R304.3.2

Compliance	Description	Data	Compliance	Description	Data
N/A	Ramp Length LT (in)	46.0	N/A	Ramp Length RT (in)	61.0
Yes	Ramp Width LT (in)	60.0	Yes	Ramp Width RT (in)	60.0
No	Ramp Slope LT (%)	10.8	Yes	Ramp Slope RT (%)	1.0
Yes	Ramp XSlope LT (%)	1.8	No	Ramp XSlope RT (%)	2.9
N/A	Ramp Length (in)	73.0	Yes	Ramp Slope (%)	6.4
Yes	Ramp Width (in)	48.0	No	Ramp XSlope (%)	3.8
N/A	Flare Type LT	N/A	N/A	Flare Type RT	N/A
N/A	Flare Slope LT (%)	N/A	N/A	Flare Slope RT (%)	N/A
N/A	Flare Traversable LT?	N/A	N/A	Flare Traversable RT?	N/A
N/A	Landing Length (in)	N/A	N/A	DWS Provided?	N/A
N/A	Landing Width (in)	N/A	N/A	DWS Contrast?	N/A
N/A	Landing Slope (%)	N/A	N/A	DWS Length (in)	N/A
N/A	Landing X Slope (%)	N/A	N/A	DWS Full Width?	N/A
N/A	Landing Curb? (Y/N)	N/A	N/A	DWS Offset (in)	N/A
N/A	Shared Landing?	N/A			
N/A	Gutter Ponding?	N/A	N/A	Gutter Slope (%)	N/A
N/A	Gutter Lip Ht (in)	N/A	N/A	Gutter X Slope (%)	N/A
N/A	Painted X Walk1?	No	N/A	Painted X Walk2?	N/A

Remove & Replace Entire Ramp.
