Access Compliance Report Public Rights-of-Way (Curb Ramps)

Intersection ID: 44922 Main Street: MAPLE_PARK_LN Cross Street: ROBUR_CT Location: NW

ADA ID: CFFC95028DDB Ramp Type: PerpDiag Initial Pass/Fail: Fail Overall Compliance: No Severity Score: 10

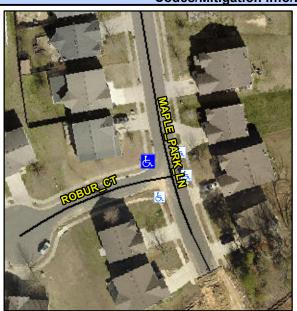
Not Found, R304.5.1, R304.5.3

Field Measurements/Component Compliance					
Compliance Description		Data	Compliance Description		Data
N/A	Ramp Length (in)	46.0	Yes	Ramp Slope (%)	6.9
No	Ramp Width (in)	39.0	No	Ramp XSlope (%)	3.2
N/A	Flare Type LT	N/A	N/A	Flare Type RT	N/A
N/A	Flare Slope LT (%)	N/A	N/A	Flare Slope RT (%)	N/A
N/A	Flare Traversable LT?	N/A	N/A	Flare Traversable RT?	N/A
N/A	Landing Length (in)	N/A	N/A	DWS Provided?	N/A
N/A	Landing Width (in)	N/A	N/A	DWS Contrast?	N/A
N/A	Landing Slope (%)	N/A	N/A	DWS Length (in)	N/A
N/A	Landing X Slope (%)	N/A	N/A	DWS Full Width?	N/A
N/A	Landing Curb? (Y/N)	N/A	N/A	DWS Offset (in)	N/A
N/A	Shared Landing?	N/A			
N/A	Gutter Ponding?	N/A	N/A	Gutter Slope (%)	N/A
N/A	Gutter Lip Ht (in)	N/A	N/A	Gutter X Slope (%)	N/A
N/A	Painted X Walk1?	No	N/A	Painted X Walk2?	No
	X Walk 1 Direction	To S		X Walk 2 Direction	To E
N/A	X Walk 1 Width (in)	N/A	N/A	X Walk 2 Width (in)	N/A
	X Walk 1 Slope (%)	0.3		X Walk 2 Slope (%)	2.2

X Walk 1 X Slope (%)	1.3		X Walk 2 X Slope (%)	2.0
N/A	Ramp inside XWalk1?	N/A	N/A	Ramp inside XWalk2?	N/A
	Road Slope (%)	1.2	N/A	Clear Space?	N/A
	Road X Slope (%)	4.2	N/A	Clear Space to XWalk (in)	N/A
N/A	Any Obstructions?	N/A	N/A	Storm Grate/Utility Hazard?	N/A
	Obstruction Type		l	Storm Grate/Utility Type	
		N/A			N/A
			Yes	Surface Condition? (G/P)	Good

Remove & Replace Curb Ramp With Two New Directional Ramps or Equivalent.
