## **Access Compliance Report Public Rights-of-Way** (Curb Ramps)

Intersection ID: 30009 Main Street: BACKWATER DR Cross Street: OLD\_CAROLINA\_DR Location: SE ADA ID: D066887F0EF2 Ramp Type: PerpDiag Initial Pass/Fail: Fail **Overall Compliance: No Severity Score:** 25

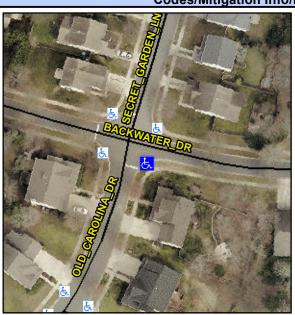
| Field Measurements/Component Compliance | | | | | |
|---|---|---|---|---|---|
| N/A | Ramp Length (in) | 32.0 | No | Ramp Slope (%) | 10.3 |
| Yes | Ramp Width (in) | 48.0 | No | Ramp XSlope (%) | 5.1 |

Possible Solutions: Remove & Replace Curb Ramp With **Two New Directional Ramps or** Equivalent. Surveyor Notes: N/A PROW/ADA: Not Found, R304.2.2, R304.5.3
