Access Compliance Report

Public Rights-of-Way

(Curb Ramps)

Intersection ID: 14341	Main Street: BAY_ST	Cross Street: LORNA_ST	Location: S
ADA ID: D0CAFC96C7D4	Ramp Type: Perp	Initial Pass/Fail: Fail	Overall Compliance: No
Severity Score: 12.5			
Codes/Mitigation Info/Possible Solution		Field Measurements/Component Compliance

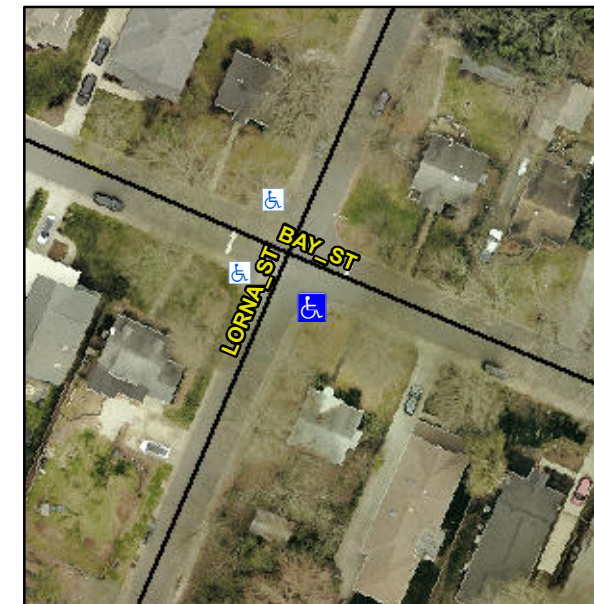
Not Found, R304.5.3

Compliance	Description	Data	Compliance	Description	Data
N/A	Ramp Length (in)	60.0	Yes	Ramp Slope (%)	5.7
Yes	Ramp Width (in)	48.0	No	Ramp XSlope (%)	5.2
N/A	Flare Type LT	N/A	N/A	Flare Type RT	N/A
N/A	Flare Slope LT (%)	N/A	N/A	Flare Slope RT (%)	N/A
N/A	Flare Traversable LT?	N/A	N/A	Flare Traversable RT?	N/A
N/A	Landing Length (in)	N/A	N/A	DWS Provided?	N/A
N/A	Landing Width (in)	N/A	N/A	DWS Contrast?	N/A
N/A	Landing Slope (%)	N/A	N/A	DWS Length (in)	N/A
N/A	Landing X Slope (%)	N/A	N/A	DWS Full Width?	N/A
N/A	Landing Curb? (Y/N)	N/A	N/A	DWS Offset (in)	N/A
N/A	Shared Landing?	N/A			
N/A	Gutter Ponding?	N/A	N/A	Gutter Slope (%)	N/A
N/A	Gutter Lip Ht (in)	N/A	N/A	Gutter X Slope (%)	N/A
N/A	Painted X Walk1?	No	N/A	Painted X Walk2?	N/A
	X Walk 1 Direction	To NW		X Walk 2 Direction	N/A
N/A	X Walk 1 Width (in)	N/A	N/A	X Walk 2 Width (in)	N/A
	X Walk 1 Slope (%)	3.7		X Walk 2 Slope (%)	N/A
	X Walk 1 X Slope (%)	0.6		X Walk 2 X Slope (%)	N/A

Remove & Replace Entire Ramp.
