Access Compliance Report Public Rights-of-Way (Curb Ramps)

Intersection ID: 10031407 Main Street: MCALPINE_STATION_DR Cross Street: N/A Location: SW **Overall Compliance: No** ADA ID: D0FB3A297A27 Ramp Type: Directional1 Initial Pass/Fail: Pass **Severity Score:** 0.25

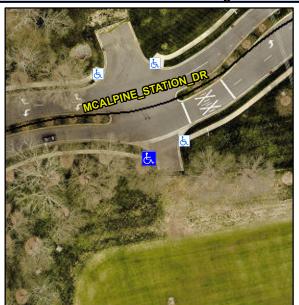
_					
Comp	liance Description	Data	Com	pliance Description	Data
N/A	Ramp Length (in)	95.0	Yes	Grade Break?	Yes
Yes	Ramp Width (in)	60.0	Yes	Grade Break Slope (%)	1.3
Yes	Ramp Slope (%)	1.5	Yes	Grade Break XSlope (%)	1.9
No	Ramp XSlope (%)	2.9			
Yes	Flare Type LT	N/A	Yes	Flare Type RT	N/A
N/A	Flare Slope LT (%)	N/A	N/A	Flare Slope RT (%)	N/A
N/A	Flare Traversable LT?	No	N/A	Flare Traversable RT?	No
Yes	Landing Length (in)	64.0	Yes	DWS Provided?	Yes
Yes	Landing Width (in)	48.0	Yes	DWS Contrast?	Yes
Yes	Landing Slope (%)	0.4	Yes	DWS Length (in)	24.0
No	Landing X Slope (%)	2.4	Yes	DWS Full Width?	Yes
N/A	Landing Curb? (Y/N)	No	Yes	DWS Offset LT (in)	28.0
N/A	Shared Landing?	No	No	DWS Offset RT (in)	5.0
Yes	Gutter Ponding?	No	Yes	Gutter Slope (%)	2.4
Yes	Gutter Lip Ht (in)	0.0	Yes	Gutter X Slope (%)	1.3
N/A	Painted X Walk1?	No		Road Slope (%)	0.7
	X Walk 1 Direction	To NE		Road X Slope (%)	0.6
	X Walk 1 Width (in)	N/A		Clear Space?	Yes

X Walk 1 Slope (%)	0.7	N/A	Clear Space to XWalk (in)	N/A
	X Walk 1 X Slope (%)	0.6	Yes	Storm Grate/Utility Hazard?	No
N/A	Ramp inside XWalk1?	N/A		Storm Grate/Utility Type	
Yes	Any Obstructions?	No			N/A
	Obstruction Type		Yes	Surface Condition? (G/P)	Good
		N/A	N/A	Curb Slope (%)	12.4

Possible Solution		
Possible Solutions:	Comp	liance De
Remove & Replace Entire Ramp.	N/A	Ramp Le
·	Yes	Ramp W
	Yes	Ramp SI
	No	Ramp XS
	Yes	Flare Ty _l
	N/A	Flare Slo
Surveyor Notes:	N/A	Flare Tra
N/A	Yes	Landing
	Yes	Landing
	Yes	Landing
	No	Landing
PROW/ADA:	N/A	Landing
R304.5.3, R305.2	N/A	Shared L
	Yes	Gutter P
	Yes	Gutter Li
	N/A	Painted 2
		X Walk 1
		X Walk 1
		X Walk 1
		V M-II. 4
