Access Compliance Report

Public Rights-of-Way

(Curb Ramps)

Intersection ID: 2671	Main Street: ELBERON_CT	Cross Street: MCCHESENEY_DR	Location:	N
ADA ID: D117E33CD356	Ramp Type: Combination1	Initial Pass/Fail: Fail	Overall Compliance: No	Severity Score: 46.25
Codes/Mitigation Info/Possible Solution		Field Measurements/Component Compliance

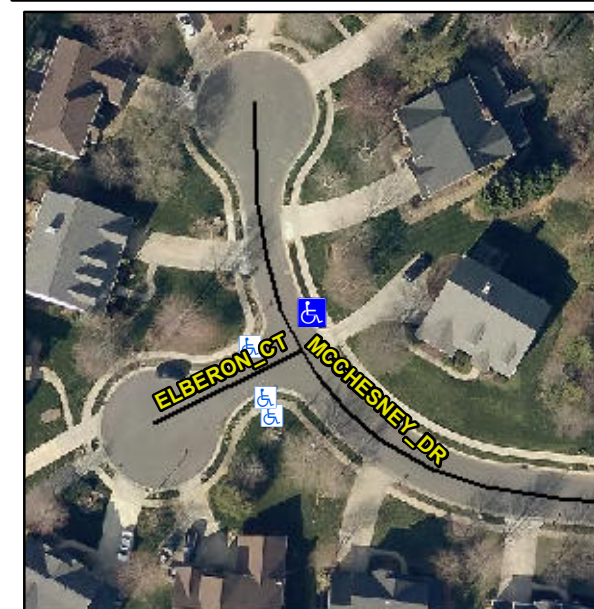
**R304.5.1, R304.5.1, R304.2.2,
R304.5.3, R304.3.2**

Compliance	Description	Data	Compliance	Description	Data
N/A	Ramp Length LT (in)	69.5	N/A	Ramp Length RT (in)	60.0
Yes	Ramp Width LT (in)	48.0	No	Ramp Width RT (in)	47.0
No	Ramp Slope LT (%)	9.6	Yes	Ramp Slope RT (%)	7.9
No	Ramp XSlope LT (%)	4.6	No	Ramp XSlope RT (%)	3.8
N/A	Ramp Length (in)	45.0	No	Ramp Slope (%)	9.1
No	Ramp Width (in)	46.0	No	Ramp XSlope (%)	12.0
N/A	Flare Type LT	N/A	N/A	Flare Type RT	N/A
N/A	Flare Slope LT (%)	N/A	N/A	Flare Slope RT (%)	N/A
N/A	Flare Traversable LT?	N/A	N/A	Flare Traversable RT?	N/A
N/A	Landing Length (in)	N/A	N/A	DWS Provided?	N/A
N/A	Landing Width (in)	N/A	N/A	DWS Contrast?	N/A
N/A	Landing Slope (%)	N/A	N/A	DWS Length (in)	N/A
N/A	Landing X Slope (%)	N/A	N/A	DWS Full Width?	N/A
N/A	Landing Curb? (Y/N)	N/A	N/A	DWS Offset (in)	N/A
N/A	Shared Landing?	N/A			
N/A	Gutter Ponding?	N/A	N/A	Gutter Slope (%)	N/A
N/A	Gutter Lip Ht (in)	N/A	N/A	Gutter X Slope (%)	N/A
N/A	Painted X Walk1?	No	N/A	Painted X Walk2?	N/A

Remove & Replace Entire Ramp.
