# Access Compliance Report

## Public Rights-of-Way

### (Curb Ramps)

Intersection ID: 48304	Main Street: FAZENDA_DR	Cross Street: GANSO_LN	Location:	N
ADA ID: D186696020EE	Ramp Type: PerpDiag	Initial Pass/Fail: Fail	Overall Compliance: No	Severity Score: 25
Codes/Mitigation Info/Possible Solution		Field Measurements/Component Compliance

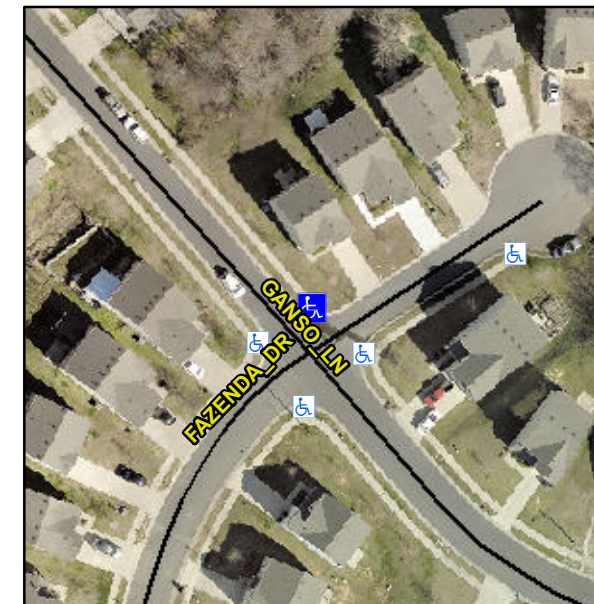
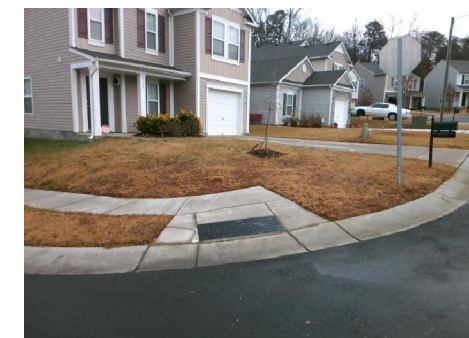
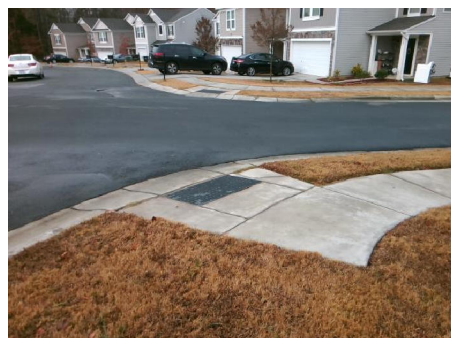
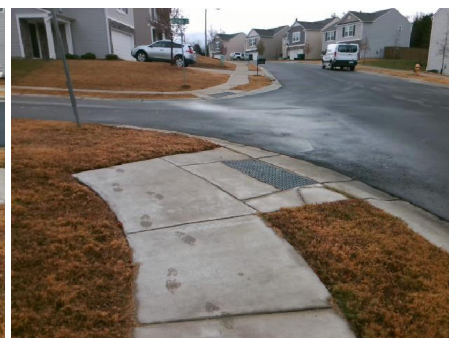
**Not Found, R304.5.3**

Compliance	Description	Data	Compliance	Description	Data
N/A	Ramp Length (in)	51.0	Yes	Ramp Slope (%)	7.2
Yes	Ramp Width (in)	48.0	No	Ramp XSlope (%)	7.9
N/A	Flare Type LT	N/A	N/A	Flare Type RT	N/A
N/A	Flare Slope LT (%)	N/A	N/A	Flare Slope RT (%)	N/A
N/A	Flare Traversable LT?	N/A	N/A	Flare Traversable RT?	N/A
N/A	Landing Length (in)	N/A	N/A	DWS Provided?	N/A
N/A	Landing Width (in)	N/A	N/A	DWS Contrast?	N/A
N/A	Landing Slope (%)	N/A	N/A	DWS Length (in)	N/A
N/A	Landing X Slope (%)	N/A	N/A	DWS Full Width?	N/A
N/A	Landing Curb? (Y/N)	N/A	N/A	DWS Offset (in)	N/A
N/A	Shared Landing?	N/A			
N/A	Gutter Ponding?	N/A	N/A	Gutter Slope (%)	N/A
N/A	Gutter Lip Ht (in)	N/A	N/A	Gutter X Slope (%)	N/A
N/A	Painted X Walk1?	No	N/A	Painted X Walk2?	No
	X Walk 1 Direction	To SW		X Walk 2 Direction	To SE
N/A	X Walk 1 Width (in)	N/A	N/A	X Walk 2 Width (in)	N/A
	X Walk 1 Slope (%)	0.7		X Walk 2 Slope (%)	7.3
	X Walk 1 X Slope (%)	9.6		X Walk 2 X Slope (%)	2.0

**Remove & Replace Curb Ramp With Two New Directional Ramps or Equivalent.**
