## **Access Compliance Report Public Rights-of-Way** (Curb Ramps)

Intersection ID: 12150 Main Street: W\_MARTIN\_LUTHER\_KING\_JRCBO6s Street: S\_GRAHAM\_ST Location:

Severity Score: 26.25 **Overall Compliance: No** ADA ID: D196B901436E Ramp Type: Perp Initial Pass/Fail: Fail

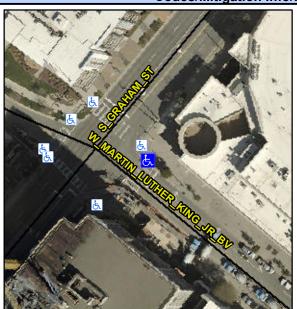
1 OSSIDIE SOIGHOIT		
Possible Solutions:	<u>c</u>	
Remove & Replace Entire Ramp.		
·	Υ	
	N	
	N	
	N	
	N	
Surveyor Notes:	N	
N/A	N	
	N	
	N	
	N	
PROW/ADA:	N	
Not Found, R304.2.2, R304.5.3	N	
	N	
	N

Field Measurements/Component Compliance									
	Compliance Description		Data	Comp	liance Description	Data			
	N/A	Ramp Length (in)	78.0	No	Ramp Slope (%)	12.3			
	Yes	Ramp Width (in)	48.0	No	Ramp XSlope (%)	3.6			
	N/A	Flare Type LT	N/A	N/A	Flare Type RT	N/A			
	N/A	Flare Slope LT (%)	N/A	N/A	Flare Slope RT (%)	N/A			
	N/A	Flare Traversable LT?	N/A	N/A	Flare Traversable RT?	N/A			
	N/A	Landing Length (in)	N/A	N/A	DWS Provided?	N/A			
	N/A	Landing Width (in)	N/A	N/A	DWS Contrast?	N/A			
	N/A	Landing Slope (%)	N/A	N/A	DWS Length (in)	N/A			
	N/A	Landing X Slope (%)	N/A	N/A	DWS Full Width?	N/A			
	N/A	Landing Curb? (Y/N)	N/A	N/A	DWS Offset (in)	N/A			
	N/A	Shared Landing?	N/A						
	N/A	Gutter Ponding?	N/A	N/A	Gutter Slope (%)	N/A			
	N/A	Gutter Lip Ht (in)	N/A	N/A	Gutter X Slope (%)	N/A			
	N/A	Painted X Walk1?	Yes	N/A	Painted X Walk2?	N/A			
		X Walk 1 Direction	To SW		X Walk 2 Direction	N/A			
	N/A	X Walk 1 Width (in)	172.0	N/A	X Walk 2 Width (in)	N/A
