Access Compliance Report

Public Rights-of-Way

(Curb Ramps)

Intersection ID: 8804	Main Street: OREGON_ST	Cross Street: ROZZELLES_FERRY_RD	Location: W
ADA ID: D1E0729097EF	Ramp Type: Combination1Diag	Initial Pass/Fail: Fail	Overall Compliance: No
		Severity Score: 0

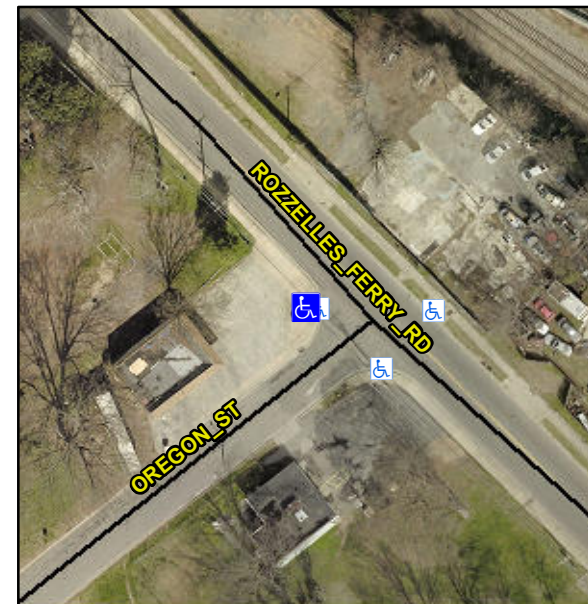
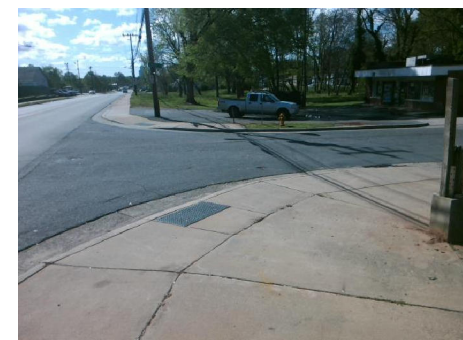
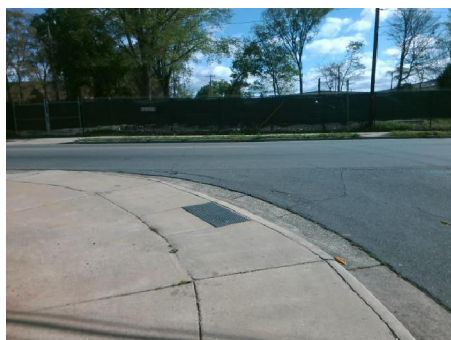
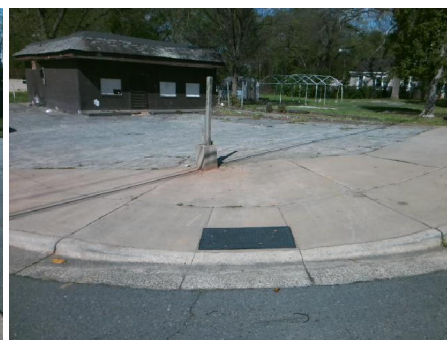
RP & LT RP < 5%

Not Found, R304.5.1, R304.5.3, R304.3.2

Remove & Replace Curb Ramp With Two New Directional Ramps or Equivalent.
