Access Compliance Report Public Rights-of-Way (Curb Ramps)

Intersection ID: 45834 Main Street: PATRICIA ANN LN **Cross Street: KELDEN WALKER LN** Location: Ε ADA ID: D27268D5507D Ramp Type: PerpDiag Initial Pass/Fail: Fail **Overall Compliance: No Severity Score:** 30

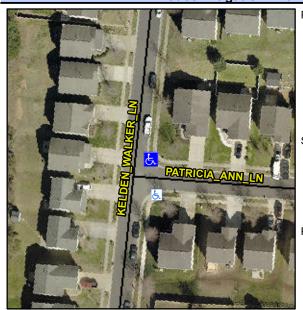
Field Measurements/Component Compliance					
Compliance Description		Data	Comp	oliance Description	Data
N/A	Ramp Length (in)	48.0	No	Ramp Slope (%)	8.6
No	Ramp Width (in)	32.5	Yes	Ramp XSlope (%)	1.9
N/A	Flare Type LT	N/A	N/A	Flare Type RT	N/A
N/A	Flare Slope LT (%)	N/A	N/A	Flare Slope RT (%)	N/A
N/A	Flare Traversable LT?	N/A	N/A	Flare Traversable RT?	N/A
N/A	Landing Length (in)	N/A	N/A	DWS Provided?	N/A
N/A	Landing Width (in)	N/A	N/A	DWS Contrast?	N/A
N/A	Landing Slope (%)	N/A	N/A	DWS Length (in)	N/A
N/A	Landing X Slope (%)	N/A	N/A	DWS Full Width?	N/A
N/A	Landing Curb? (Y/N)	N/A	N/A	DWS Offset (in)	N/A
N/A	Shared Landing?	N/A			
N/A	Gutter Ponding?	N/A	N/A	Gutter Slope (%)	N/A
N/A	Gutter Lip Ht (in)	N/A	N/A	Gutter X Slope (%)	N/A
N/A	Painted X Walk1?	No	N/A	Painted X Walk2?	No
	X Walk 1 Direction	To W		X Walk 2 Direction	To S
N/A	X Walk 1 Width (in)	N/A	N/A	X Walk 2 Width (in)	N/A
	X Walk 1 Slope (%)	0.6		X Walk 2 Slope (%)	4.1

X Walk 1 X Slope (%)	4.0		X Walk 2 X Slope (%)	1.9
N/A	Ramp inside XWalk1?	N/A	N/A	Ramp inside XWalk2?	N/A
	Road Slope (%)	4.7	N/A	Clear Space?	N/A
	Road X Slope (%)	1.8	N/A	Clear Space to XWalk (in)	N/A
N/A	Any Obstructions?	N/A	N/A	Storm Grate/Utility Hazard?	N/A
	Obstruction Type			Storm Grate/Utility Type	
		N/A			N/A
			Yes	Surface Condition? (G/P)	Good

Possible Solutions: **Remove & Replace Curb Ramp With Two New Directional Ramps or** Equivalent. Surveyor Notes: N/A PROW/ADA: Not Found, R304.5.1, R304.2.2
