Access Compliance Report

Public Rights-of-Way

| Intersection ID: 27649 | Main Street: BALLANTYNE_COUNTRY_CLUB_DR | Cross Street: ROBINSON_ROCK_CT | Location: NW |
| ADA ID: D28FDC0E63E3 | Ramp Type: BlendTrans2 | Initial Pass/Fail: Fail | Overall Compliance: No |

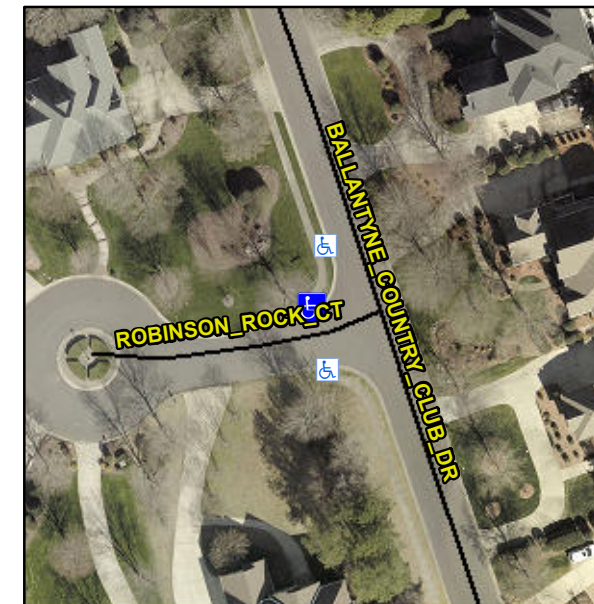
Not Found, R304.5.1, R304.5.3

| Compliance | Description | Data | Compliance | Description | Data |
|---|---|---|---|---|---|
| No | Ramp Width (in) | 46.0 | No | BlendTrans XSlope (%) | 4.5 |

Remove & Replace Curb Ramp With Two New Directional Ramps or Equivalent.

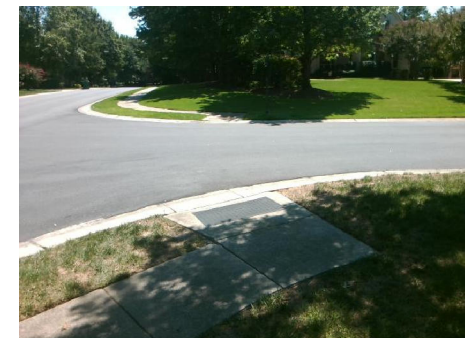
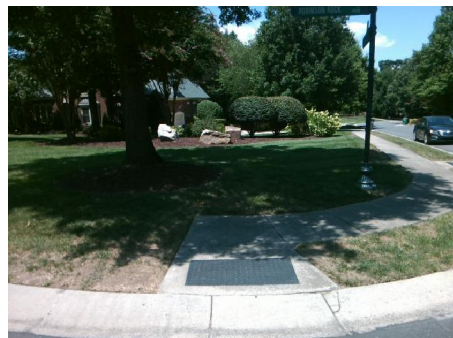
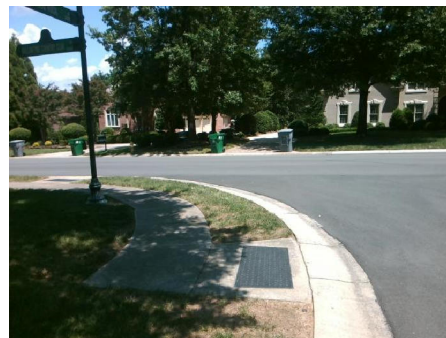
| Compliance | Description | Data | Compliance | Description | Data |
|---|---|---|---|---|---|
| | | | No | Curb Slope (%) | 8.0 |
