Access Compliance Report

Public Rights-of-Way

(Curb Ramps)

| Intersection ID: 19132 | Main Street: CHASEWOOD_DR | Cross Street: MONROE_RD | Location: NW |

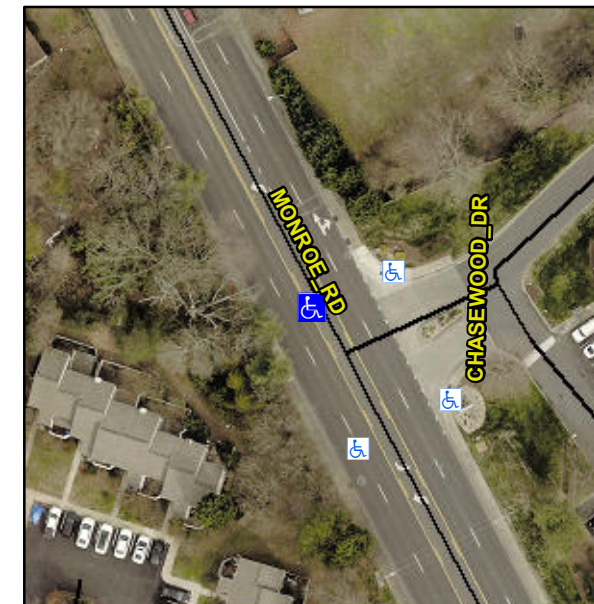
| ADA ID: D292DD654DAD | Ramp Type: Para | Initial Pass/Fail: Fail | Overall Compliance: No |
| Severity Score: 13.75 | | | |

R304.3.2, R304.5.3

| Compliance | Description | Data | Compliance | Description | Data |
|---|---|---|---|---|---|
| Yes | Ramp Slope LT (%) | 5.1 | No | Ramp Slope RT (%) | 9.0 |
| Yes | Ramp XSlope LT (%) | 1.9 | No | Ramp XSlope RT (%) | 2.3 |

Remove & Replace Entire Ramp.
