## Access Compliance Report Public Rights-of-Way (Curb Ramps)

Intersection ID: 5212 Main Street: BELLHAVEN\_BV Cross Street: CAMERON\_SPRING\_RD Location: S

ADA ID: D2B87FB72DFA Ramp Type: Perp Initial Pass/Fail: Fail Overall Compliance: No Severity Score: 33.75

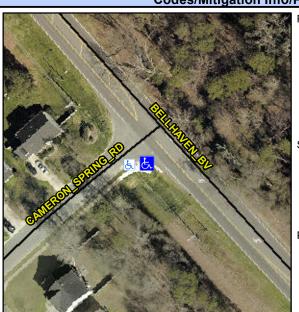
Not Found, R304.5.1, R304.2.2, R304.5.3

Field Measurements/Component Compliance								
Comp	liance Description	Data	Compl	iance	Description	Data		
N/A	Ramp Length (in)	49.0	No	Ramp	Slope (%)	10.4		
No	Ramp Width (in)	44.0	No	Ramp	XSlope (%)	5.7		
N/A	Flare Type LT	N/A	N/A	Flare	Type RT	N/A		
N/A	Flare Slope LT (%)	N/A	N/A	Flare	Slope RT (%)	N/A		
N/A	Flare Traversable LT?	N/A	N/A	Flare	Traversable RT?	N/A		
N/A	Landing Length (in)	N/A	N/A	DWS	Provided?	N/A		
N/A	Landing Width (in)	N/A	N/A	DWS	Contrast?	N/A		
N/A	Landing Slope (%)	N/A	N/A	DWS	Length (in)	N/A		
N/A	Landing X Slope (%)	N/A	N/A	DWS	Full Width?	N/A		
N/A	Landing Curb? (Y/N)	N/A	N/A	DWS	Offset (in)	N/A		
N/A	Shared Landing?	N/A						
N/A	Gutter Ponding?	N/A	N/A	Gutte	r Slope (%)	N/A		
N/A	Gutter Lip Ht (in)	N/A	N/A	Gutte	r X Slope (%)	N/A		
N/A	Painted X Walk1?	No	N/A	Paint	ed X Walk2?	N/A		
	X Walk 1 Direction	To NE		X Wa	lk 2 Direction	N/A		
N/A	X Walk 1 Width (in)	N/A	N/A	X Wa	lk 2 Width (in)	N/A

X Walk 1 Slope (%)	3.6		X Wa	lk 2 Slope (%)	N/A		
	X Walk 1 X Slope (%)	5.0		X Wa	lk 2 X Slope (%)	N/A		
N/A	Ramp inside XWalk1?	N/A	N/A	Ramp	inside XWalk2?	N/A		
	Road Slope (%)	5.0	N/A	Clear	Space?	N/A		
	Road X Slope (%)	3.6	N/A	Clear	Space to XWalk (in)	N/A		
N/A	Any Obstructions?	N/A	N/A	Storm	n Grate/Utility Hazard?	N/A		
	Obstruction Type			Storm	n Grate/Utility Type			
		N/A				N/A		
			Yes	Surfa	ce Condition? (G/P)	Good

Remove & Replace Entire Ramp.
