Access Compliance Report Public Rights-of-Way (Curb Ramps)

Intersection ID: 23537 Main Street: KIRCHENBAUM_DR Cross Street: OBERBECK_LN Location: N

ADA ID: D35F6A072F33 Ramp Type: PerpDiag Initial Pass/Fail: Fail Overall Compliance: No Severity Score: 33.75

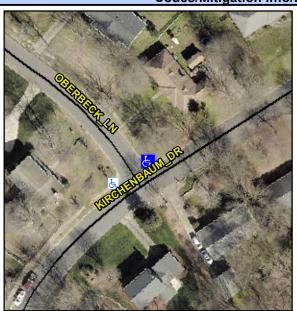
PROW/ADA:
R304.5.1, R304.2.2, R304.5.3

Compliance Description		Data	Compliance Description		Data
N/A	Ramp Length (in)	47.0	No	Ramp Slope (%)	8.5
No	Ramp Width (in)	47.0	No	Ramp XSlope (%)	5.5
N/A	Flare Type LT	N/A	N/A	Flare Type RT	N/A
N/A	Flare Slope LT (%)	N/A	N/A	Flare Slope RT (%)	N/A
N/A	Flare Traversable LT?	N/A	N/A	Flare Traversable RT?	N/A
N/A	Landing Length (in)	N/A	N/A	DWS Provided?	N/A
N/A	Landing Width (in)	N/A	N/A	DWS Contrast?	N/A
N/A	Landing Slope (%)	N/A	N/A	DWS Length (in)	N/A
N/A	Landing X Slope (%)	N/A	N/A	DWS Full Width?	N/A
N/A	Landing Curb? (Y/N)	N/A	N/A	DWS Offset (in)	N/A
N/A	Shared Landing?	N/A			
N/A	Gutter Ponding?	N/A	N/A	Gutter Slope (%)	N/A
N/A	Gutter Lip Ht (in)	N/A	N/A	Gutter X Slope (%)	N/A
N/A	Painted X Walk1?	No	N/A	Painted X Walk2?	No
	X Walk 1 Direction	To W		X Walk 2 Direction	To S
N/A	X Walk 1 Width (in)	N/A	N/A	X Walk 2 Width (in)	N/A
	X Walk 1 Slope (%)	2.4		X Walk 2 Slope (%)	7.1
	X Walk 1 X Slope (%)	3.9		X Walk 2 X Slope (%)	0.2

Remove & Replace Curb Ramp With
Two New Directional Ramps or
Equivalent.
