Intersection ID: 50587	Main Street: DOWNY_BIRCH_RD	Cross Street: GREAT_LAUREL_RD	Location:	SW
ADA ID: D38CD7C1228B	Ramp Type: Perp	Initial Pass/Fail: Fail	Overall Compliance: No	Severity Score: 13.75

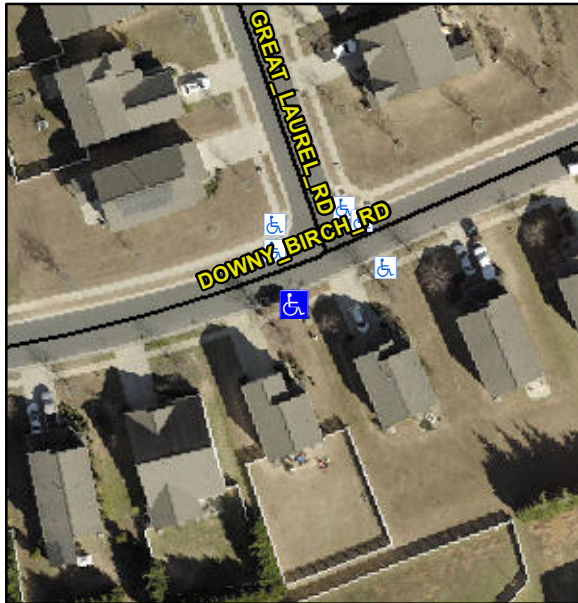
Not Found, R304.2.2, R304.5.3

Possible Solutions:			Compliance	Description	Data	Compliance	Description	Data
Remove & Replace Entire Ramp.	N/A	Ramp Length (in)	47.0	No	Ramp Slope (%)	8.6		
	Yes	Ramp Width (in)	48.0	No	Ramp XSlope (%)	2.1		
	N/A	Flare Type LT	N/A	N/A	Flare Type RT	N/A		
	N/A	Flare Slope LT (%)	N/A	N/A	Flare Slope RT (%)	N/A		
	N/A	Flare Traversable LT?	N/A	N/A	Flare Traversable RT?	N/A		
	N/A	Landing Length (in)	N/A	N/A	DWS Provided?	N/A		
	N/A	Landing Width (in)	N/A	N/A	DWS Contrast?	N/A		
	N/A	Landing Slope (%)	N/A	N/A	DWS Length (in)	N/A		
	N/A	Landing X Slope (%)	N/A	N/A	DWS Full Width?	N/A		
	N/A	Landing Curb? (Y/N)	N/A	N/A	DWS Offset (in)	N/A		
Surveyor Notes: N/A	N/A	Shared Landing?	N/A					
	N/A	Gutter Ponding?	N/A	N/A	Gutter Slope (%)	N/A		
	N/A	Gutter Lip Ht (in)	N/A	N/A	Gutter X Slope (%)	N/A		
	N/A	Painted X Walk1?	No	N/A	Painted X Walk2?	N/A		
		X Walk 1 Direction	To N		X Walk 2 Direction	N/A		
	N/A	X Walk 1 Width (in)	N/A	N/A	X Walk 2 Width (in)	N/A

Remove & Replace Entire Ramp.

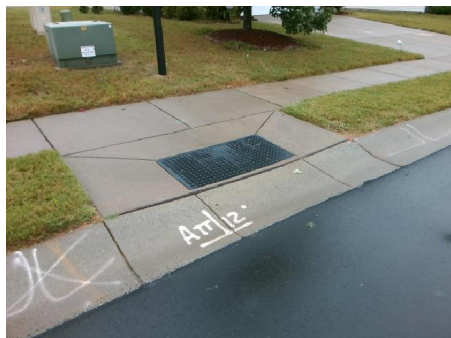
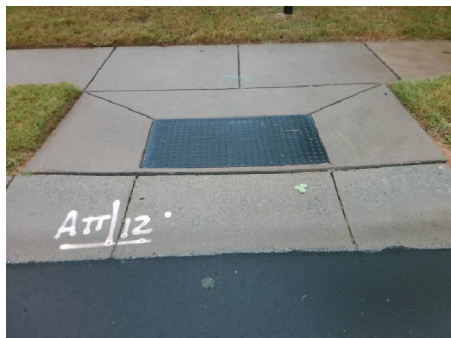
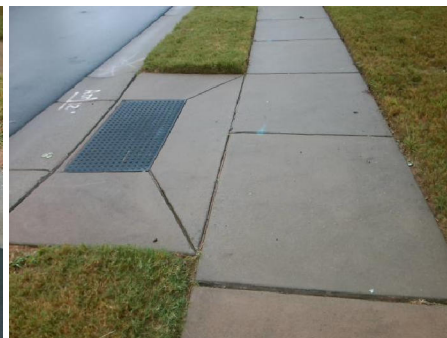
X Walk 1 Slope (%)	1.2		X Walk 2 Slope (%)	N/A		
		X Walk 1 X Slope (%)	1.9		X Walk 2 X Slope (%)	N/A		
	N/A	Ramp inside XWalk1?	N/A	N/A	Ramp inside XWalk2?	N/A		
		Road Slope (%)	N/A	N/A	Clear Space?	N/A		
PROW/ADA: Not Found, R304.2.2, R304.5.3		Road X Slope (%)	N/A	N/A	Clear Space to XWalk (in)	N/A		
	N/A	Any Obstructions?	N/A	N/A	Storm Grate/Utility Hazard?	N/A		
		Obstruction Type			Storm Grate/Utility Type			
			N/A			N/A		
				Yes	Surface Condition? (G/P)	Good		
	Total Cost:	\$	1850.00
