Access Compliance Report

Public Rights-of-Way

(Curb Ramps)

Intersection ID: 50321	Main Street: BELMAR_PLACE_RD	Cross Street: CINDY_LN	Location: NE
ADA ID: D3C5976425EA	Ramp Type: Directional1	Initial Pass/Fail: Fail	Overall Compliance: No
Severity Score: 12.5			
Codes/Mitigation Info/Possible Solution		Field Measurements/Component Compliance

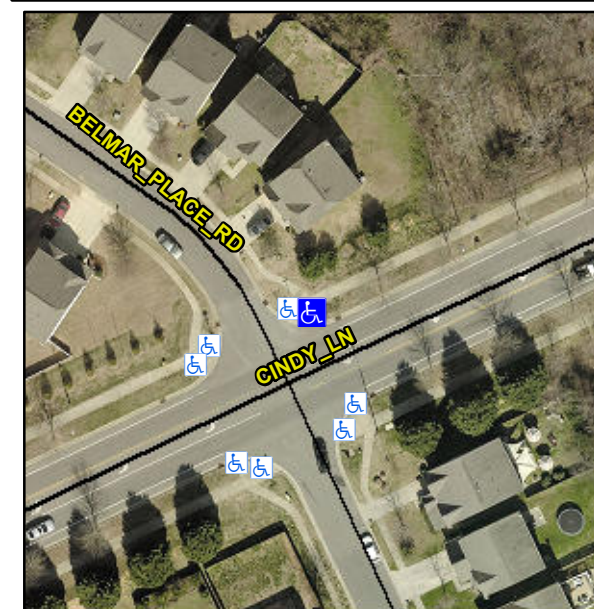
R304.2.2

Compliance	Description	Data	Compliance	Description	Data
N/A	Ramp Length (in)	72.0	N/A	Grade Break?	N/A
Yes	Ramp Width (in)	68.0	N/A	Grade Break Slope (%)	0.0
No	Ramp Slope (%)	9.6	N/A	Grade Break XSlope (%)	0.0
Yes	Ramp XSlope (%)	0.3			
N/A	Flare Type LT	N/A	N/A	Flare Type RT	N/A
N/A	Flare Slope LT (%)	N/A	N/A	Flare Slope RT (%)	0.0
N/A	Flare Traversable LT?	N/A	N/A	Flare Traversable RT?	N/A
N/A	Landing Length (in)	0.0	N/A	DWS Provided?	N/A
N/A	Landing Width (in)	0.0	N/A	DWS Contrast?	N/A
N/A	Landing Slope (%)	0.0	N/A	DWS Length (in)	N/A
N/A	Landing X Slope (%)	0.0	N/A	DWS Full Width?	N/A
N/A	Landing Curb? (Y/N)	N/A	N/A	DWS Offset LT (in)	N/A
N/A	Shared Landing?	N/A	N/A	DWS Offset RT (in)	N/A
N/A	Gutter Ponding?	0.0	N/A	Gutter Slope (%)	N/A
N/A	Gutter Lip Ht (in)	0.0	N/A	Gutter X Slope (%)	N/A
N/A	Painted X Walk1?	No		Road Slope (%)	1.7
	X Walk 1 Direction	To S		Road X Slope (%)	1.7
	X Walk 1 Width (in)	N/A		Clear Space?	N/A

Remove & Replace Entire Ramp.

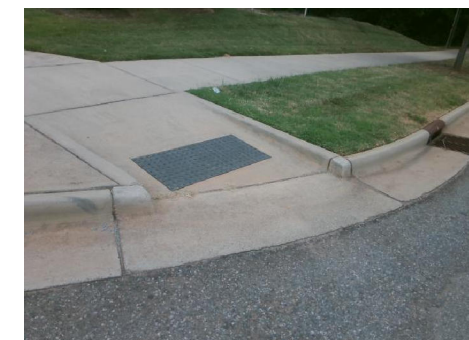
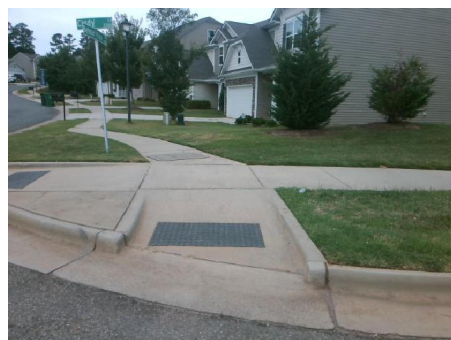
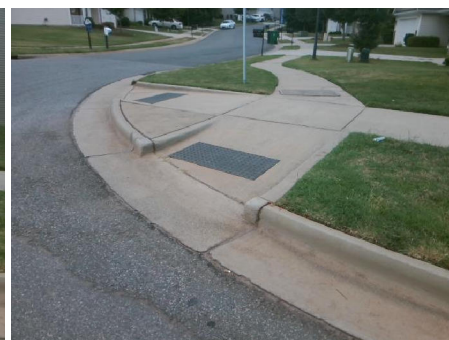
X Walk 1 Slope (%)	1.7	N/A	Clear Space to XWalk (in)	N/A
	X Walk 1 X Slope (%)	1.7	N/A	Storm Grate/Utility Hazard?	N/A
N/A	Ramp inside XWalk1?	N/A		Storm Grate/Utility Type	
N/A	Any Obstructions?	N/A			N/A
	Obstruction Type		Yes	Surface Condition? (G/P)	Good
			N/A	Curb Slope (%)	10.9
