## Access Compliance Report Public Rights-of-Way (Curb Ramps)

Intersection ID: 3539 Main Street: HARRIS\_CORNERS\_PY Cross Street: MAPLE\_VIEW\_LN Location: S

ADA ID: D488ED3ED1CB Ramp Type: Perp Initial Pass/Fail: Fail Overall Compliance: No Severity Score: 21.25

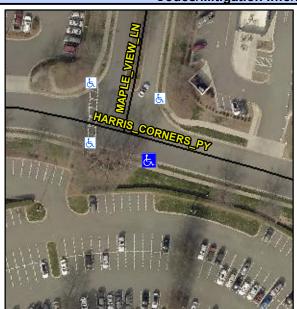
Field Measurements/Component Compliance							
Comp	liance Description	Data	Comp	liance Description	Data		
N/A	Ramp Length (in)	47.0	No	Ramp Slope (%)	11.7		
No	Ramp Width (in)	42.0	Yes	Ramp XSlope (%)	0.0		
N/A	Flare Type LT	N/A	N/A	Flare Type RT	N/A		
N/A	Flare Slope LT (%)	N/A	N/A	Flare Slope RT (%)	N/A		
N/A	Flare Traversable LT?	N/A	N/A	Flare Traversable RT?	N/A		
N/A	Landing Length (in)	N/A	N/A	DWS Provided?	N/A		
N/A	Landing Width (in)	N/A	N/A	DWS Contrast?	N/A		
N/A	Landing Slope (%)	N/A	N/A	DWS Length (in)	N/A		
N/A	Landing X Slope (%)	N/A	N/A	DWS Full Width?	N/A		
N/A	Landing Curb? (Y/N)	N/A	N/A	DWS Offset (in)	N/A		
N/A	Shared Landing?	N/A					
N/A	Gutter Ponding?	N/A	N/A	Gutter Slope (%)	N/A		
N/A	Gutter Lip Ht (in)	N/A	N/A	Gutter X Slope (%)	N/A		
N/A	Painted X Walk1?	No	N/A	Painted X Walk2?	N/A		
	X Walk 1 Direction	To N		X Walk 2 Direction	N/A		
N/A	X Walk 1 Width (in)	N/A	N/A	X Walk 2 Width (in)	N/A

Possible Solutions:  Remove & Replace Entire Ramp.  Surveyor Notes:  N/A  PROW/ADA:  R304.5.1, R304.2.2	Com N/A No
Surveyor Notes: N/A PROW/ADA:	
N/A PROW/ADA:	Nο
N/A PROW/ADA:	
N/A PROW/ADA:	N/A
PROW/ADA:	N/A
	N/A
	N/A
	N/A
	N/A
R304.5.1, R304.2.2	N/A
	N/A
	N/A
	N/A
	N/A
