Access Compliance Report

Public Rights-of-Way

(Curb Ramps)

Intersection ID: 14278	Main Street: ROMARE_BEARDEN_DR	Cross Street: FARMER_ST	Location:	S
ADA ID: D49F1F87B4D0	Ramp Type: MedianPerp	Initial Pass/Fail: Fail	Overall Compliance: No	Severity Score: 25
Codes/Mitigation Info/Possible Solution		Field Measurements/Component Compliance

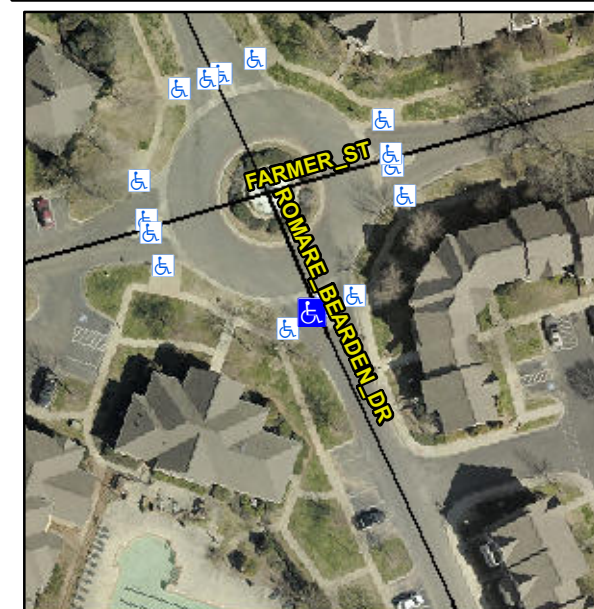
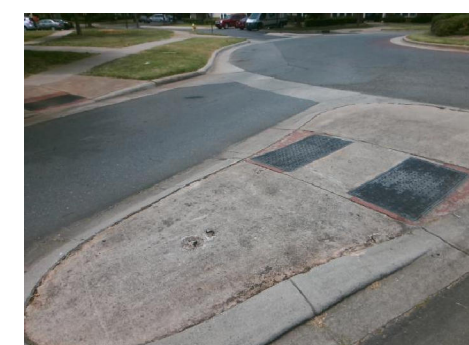
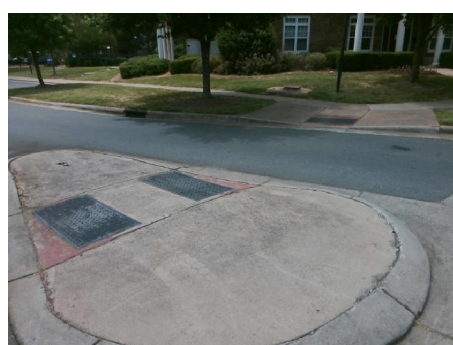
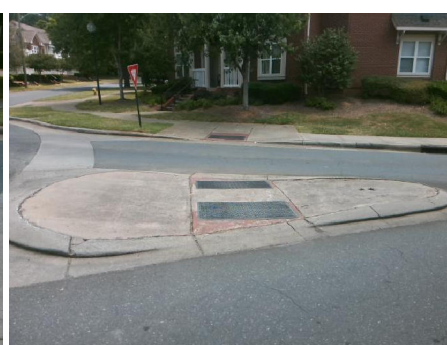
Not Found, R304.2.2, R304.5.3

Compliance	Description	Data	Compliance	Description	Data
N/A	Ramp Length (in)	35.0	No	Ramp Slope (%)	9.0
Yes	Ramp Width (in)	54.5	No	Ramp XSlope (%)	5.9
N/A	Flare Type LT	N/A	N/A	Flare Type RT	N/A
N/A	Flare Slope LT (%)	N/A	N/A	Flare Slope RT (%)	N/A
N/A	Flare Traversable LT?	N/A	N/A	Flare Traversable RT?	N/A
N/A	Landing Length (in)	N/A	N/A	DWS Provided?	N/A
N/A	Landing Width (in)	N/A	N/A	DWS Contrast?	N/A
N/A	Landing Slope (%)	N/A	N/A	DWS Length (in)	N/A
N/A	Landing X Slope (%)	N/A	N/A	DWS Full Width?	N/A
N/A	Landing Curb? (Y/N)	N/A	N/A	DWS Offset (in)	N/A
N/A	Shared Landing?	N/A			
N/A	Gutter Ponding?	N/A	N/A	Gutter Slope (%)	N/A
N/A	Gutter Lip Ht (in)	N/A	N/A	Gutter X Slope (%)	N/A
N/A	Painted X Walk1?	No	N/A	Painted X Walk2?	N/A
	X Walk 1 Direction	To W		X Walk 2 Direction	N/A
N/A	X Walk 1 Width (in)	N/A	N/A	X Walk 2 Width (in)	N/A
	X Walk 1 Slope (%)	2.1		X Walk 2 Slope (%)	N/A
	X Walk 1 X Slope (%)	1.2		X Walk 2 X Slope (%)	N/A

N/A	Ramp inside XWalk1?	N/A	N/A	Ramp inside XWalk2?	N/A
	Road Slope (%)	N/A	N/A	Clear Space?	N/A
	Road X Slope (%)	N/A	N/A	Clear Space to XWalk (in)	N/A
N/A	Any Obstructions?	N/A	N/A	Storm Grate/Utility Hazard?	N/A
	Obstruction Type			Storm Grate/Utility Type	
		N/A			N/A
			Yes	Surface Condition? (G/P)	Good

Remove & Replace Entire Ramp.
