# Access Compliance Report

## Public Rights-of-Way

### (Curb Ramps)

| Intersection ID: 16540 | Main Street: CEDAR_TREE_LN | Cross Street: CHESTNUT_LAKE_DR | Location: NW |

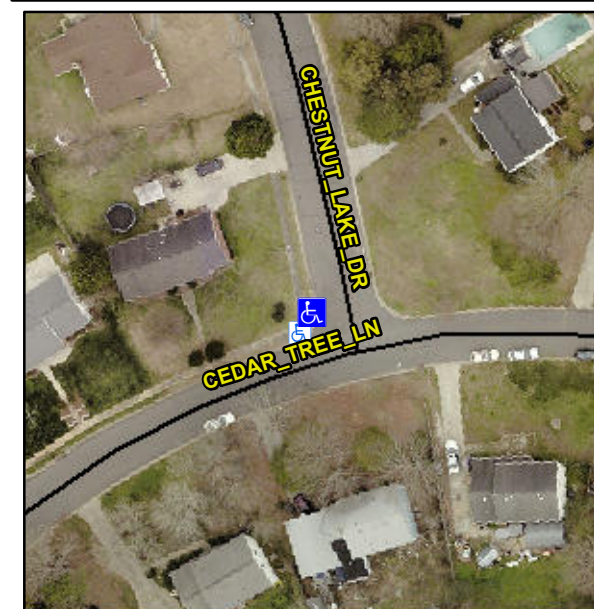
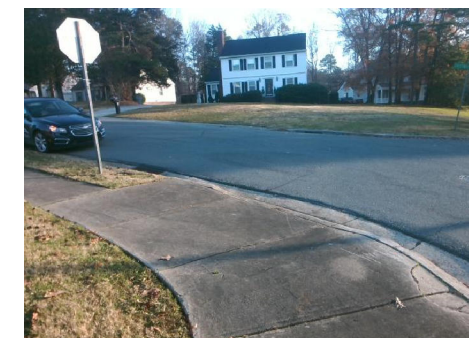
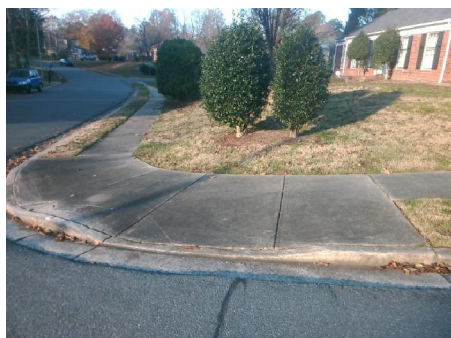
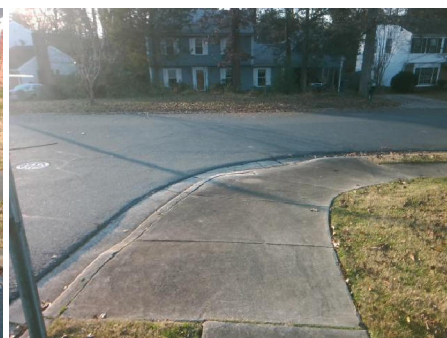
**R304.2.2, R304.5.3**

| Compliance | Description | Data | Compliance | Description | Data |
|---|---|---|---|---|---|
| N/A | Ramp Length (in) | 96.0 | No | Ramp Slope (%) | 8.8 |
| Yes | Ramp Width (in) | 55.0 | No | Ramp XSlope (%) | 8.5 |

**Remove & Replace Entire Ramp.**
