Access Compliance Report

Public Rights-of-Way

(Curb Ramps)

Intersection ID: 3853	Main Street: CADENCIA_CT	Cross Street: GLASTON_LN	Location: W
ADA ID: D4D8EC0B08BF	Ramp Type: Directional1	Initial Pass/Fail: Fail	Overall Compliance: No
Severity Score: 13.75			
Codes/Mitigation Info/Possible Solution		Field Measurements/Component Compliance

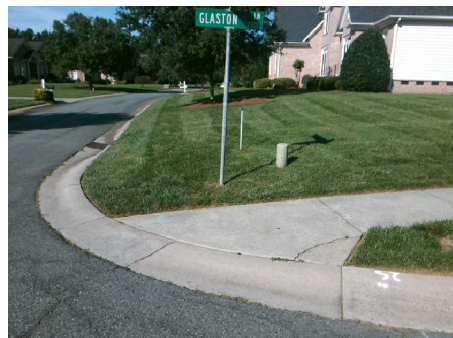
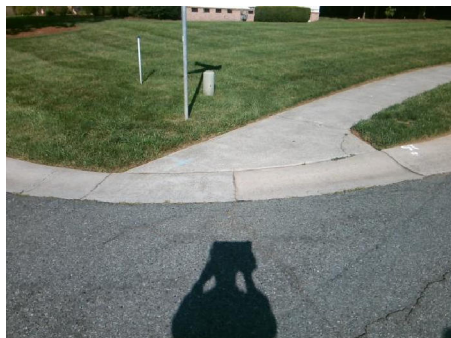
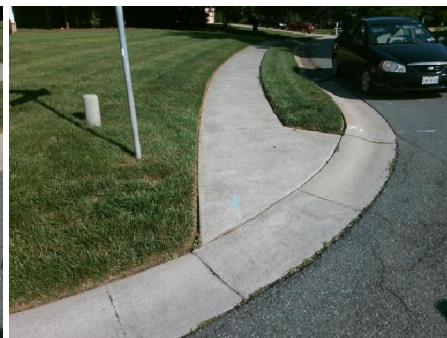
R304.2.2, R304.5.3

Compliance	Description	Data	Compliance	Description	Data
N/A	Ramp Length (in)	66.0	N/A	Grade Break?	N/A
Yes	Ramp Width (in)	50.0	N/A	Grade Break Slope (%)	0.0
No	Ramp Slope (%)	9.9	N/A	Grade Break XSlope (%)	0.0
No	Ramp XSlope (%)	2.9			
N/A	Flare Type LT	N/A	N/A	Flare Type RT	N/A
N/A	Flare Slope LT (%)	N/A	N/A	Flare Slope RT (%)	0.0
N/A	Flare Traversable LT?	N/A	N/A	Flare Traversable RT?	N/A
N/A	Landing Length (in)	0.0	N/A	DWS Provided?	N/A
N/A	Landing Width (in)	0.0	N/A	DWS Contrast?	N/A
N/A	Landing Slope (%)	0.0	N/A	DWS Length (in)	N/A
N/A	Landing X Slope (%)	0.0	N/A	DWS Full Width?	N/A
N/A	Landing Curb? (Y/N)	N/A	N/A	DWS Offset LT (in)	N/A
N/A	Shared Landing?	N/A	N/A	DWS Offset RT (in)	N/A
N/A	Gutter Ponding?	0.0	N/A	Gutter Slope (%)	N/A
N/A	Gutter Lip Ht (in)	0.0	N/A	Gutter X Slope (%)	N/A
N/A	Painted X Walk1?	No		Road Slope (%)	2.8
	X Walk 1 Direction	To SE		Road X Slope (%)	5.2
	X Walk 1 Width (in)	N/A		Clear Space?	N/A

X Walk 1 Slope (%)	2.8	N/A	Clear Space to XWalk (in)	N/A
	X Walk 1 X Slope (%)	5.2	N/A	Storm Grate/Utility Hazard?	N/A
N/A	Ramp inside XWalk1?	N/A		Storm Grate/Utility Type	
N/A	Any Obstructions?	N/A			N/A
	Obstruction Type		Yes	Surface Condition? (G/P)	Good
			N/A	Curb Slope (%)	N/A

Possible Solutions:

Remove & Replace Entire Ramp.
