Access Compliance Report

Public Rights-of-Way

(Curb Ramps)

Intersection ID: 7423	Main Street: HUMBER_CT	Cross Street: SILCHESTER_LN	Location: SE
ADA ID: D4EF7F0E3646	Ramp Type: BlendTrans1	Initial Pass/Fail: Fail	Overall Compliance: No
Severity Score: 12.5			
Codes/Mitigation Info/Possible Solution		Field Measurements/Component Compliance

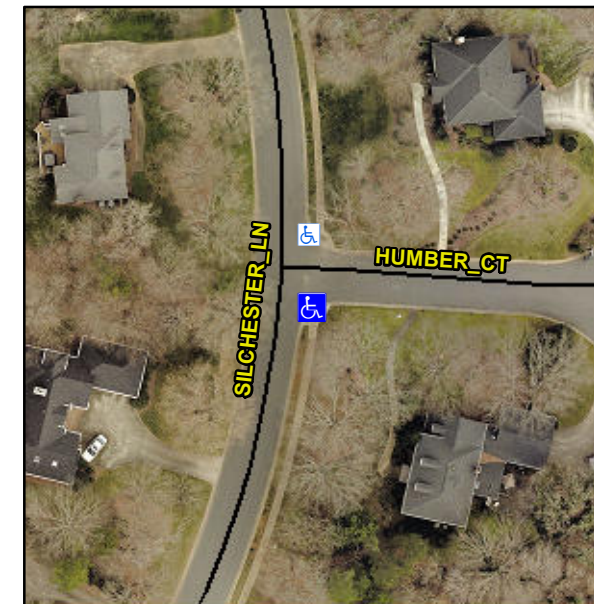
Not Found, R304.5.3

Compliance	Description	Data	Compliance	Description	Data
N/A	Ramp Length (in)	27.0	Yes	BlendTrans Slope (%)	3.5
Yes	Ramp Width (in)	48.0	No	BlendTrans XSlope (%)	5.6
N/A	Flare Type LT	N/A	N/A	Flare Type RT	N/A
N/A	Flare Slope LT (%)	N/A	N/A	Flare Slope RT (%)	N/A
N/A	Flare Traversable LT?	N/A	N/A	Flare Traversable RT?	N/A
N/A	Landing Length (in)	N/A	N/A	DWS Provided?	N/A
N/A	Landing Width (in)	N/A	N/A	DWS Contrast?	N/A
N/A	Landing Slope (%)	N/A	N/A	DWS Length (in)	N/A
N/A	Landing X Slope (%)	N/A	N/A	DWS Full Width?	N/A
N/A	Landing Curb? (Y/N)	N/A	N/A	DWS Offset (in)	N/A
N/A	Shared Landing?	N/A			
N/A	Gutter Ponding?	N/A	N/A	Gutter Slope (%)	N/A
N/A	Gutter Lip Ht (in)	N/A	N/A	Gutter X Slope (%)	N/A
N/A	Painted X Walk1?	No	N/A	Painted X Walk2?	N/A
	X Walk 1 Direction	To N		X Walk 2 Direction	N/A
	X Walk 1 Width (in)	N/A		X Walk 2 Width (in)	N/A
	X Walk 1 Slope (%)	3.0		X Walk 2 Slope (%)	N/A
	X Walk 1 X Slope (%)	2.5		X Walk 2 X Slope (%)	N/A

N/A	Ramp inside XWalk1?	N/A	N/A	Ramp inside XWalk2?	N/A
	Road Slope (%)	2.5		Clear Space?	N/A
	Road X Slope (%)	3.0	N/A	Clear Space to XWalk (in)	N/A
N/A	Any Obstructions?	N/A	N/A	Storm Grate/Utility Hazard?	N/A
	Obstruction Type			Storm Grate/Utility Type	
		N/A			N/A
			Yes	Surface Condition? (G/P)	Good
			No	Curb Slope (%)	10.6

Remove & Replace Curb Ramp With Two New Directional Ramps or Equivalent.
