Access Compliance Report Public Rights-of-Way (Curb Ramps)

•							
Intersection ID: 30487	Main Str	Main Street: BEDDINGFIELD_DR			EBULLIENT_ST	Location:	NE		
ADA ID: D57E00D2D815	Ramp Ty	Ramp Type: PerpDiag			Initial Pass/Fail: Fail Overall Compliance: No				22.5
Codes/Mitigation Info/Possible Solution				Field Measurements/Component Compliance					
		Possible Solutions:		Compliance Description			Data Compliance Description		Data
		Remove & Replace Curb Ram	With	N/A	Ramp Length (in)	85.0	No	Ramp Slope (%)	9.3
		Two New Directional Ramps or		No	Ramp Width (in)	44.0	No	Ramp XSlope (%)	5.0
		Equivalent.		N/A	Flare Type LT	N/A	N/A	Flare Type RT	N/A
				N/A	Flare Slope LT (%)	N/A		Flare Slope RT (%)	N/A
				N/A	Flare Traversable LT?	N/A		Flare Traversable RT?	N/A
	4 74 55			N/A	Landing Length (in)	N/A		DWS Provided?	N/A
	A Principal	Surveyor Notes:		N/A	Landing Width (in)	N/A	N/A	DWS Contrast?	N/A
BEDDOW		N/A		N/A	Landing Slope (%)	N/A		DWS Length (in)	N/A
PINGALEL	Dan	N/A		N/A	Landing X Slope (%)	N/A		DWS Full Width?	N/A

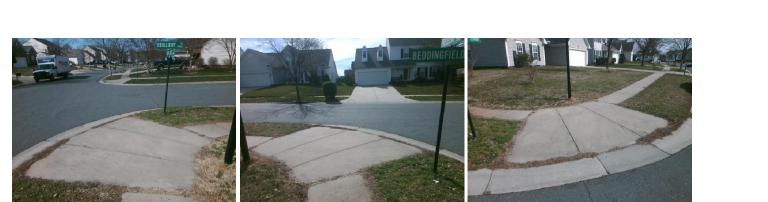
the states of th				N/A	Landing Curb? (Y/N)	N/A	N/A	DWS Offset (in)	N/A
				N/A	Shared Landing?	N/A		DWG Oliset (III)	11/2
A Manager Bar	PROW/ADA:		N/A	Gutter Ponding?	N/A	N/A	Gutter Slope (%)	N/A	
				8	N/A		,	N/A N/A	
R304.5.1, R304.2.2, R304.5.3				N/A	Gutter Lip Ht (in)			Gutter X Slope (%)	
				N/A	Painted X Walk1?	No	N/A	Painted X Walk2?	No
					X Walk 1 Direction	To NW		X Walk 2 Direction	To SW
				N/A	X Walk 1 Width (in)	N/A	N/A	X Walk 2 Width (in)	N/A
Street 1 Name	EBULLIENT ST				X Walk 1 Slope (%)	2.7		X Walk 2 Slope (%)	2.9
Stop Condition-Street 2	StopSign				X Walk 1 X Slope (%)	0.3		X Walk 2 X Slope (%)	3.6
Street 2 Name	BEDDINGFIELD DR			N/A	Ramp inside XWalk1?	N/A	N/A	Ramp inside XWalk2?	N/A
Stop Condition-Street 1	None				Road Slope (%)	3.4	N/A	Clear Space?	N/A
					Road X Slope (%)	0.1	N/A	Clear Space to XWalk (in)	N/A
				N/A	Any Obstructions?	N/A	N/A	Storm Grate/Utility Hazard?	N/A

Total Cost: \$	3200.00		Obstruction Type			Storm Grate/Utility Type	
						N/A			N/A
