Access Compliance Report Public Rights-of-Way (Curb Ramps)

Intersection ID: N/A	Main Street: N_TRYON_ST	Cross Street: W_29TH_ST	Location: NW
ADA ID: D5A0C42382E8	Ramp Type: Combination1Diag	Initial Pass/Fail: Fail	Overall Compliance: No Severity Score: 0

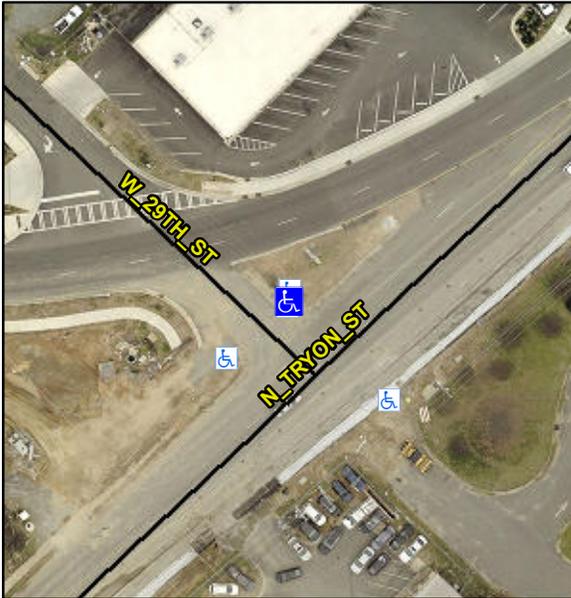
PROW/ADA:
Not Found, R304.2.2, R304.5.3

Compliance	Description	Data	Compliance	Description	Data
N/A	Ramp Length LT (in)	32.0	N/A	Ramp Length RT (in)	31.0
Yes	Ramp Width LT (in)	60.5	Yes	Ramp Width RT (in)	51.0
Yes	Ramp Slope LT (%)	8.0	Yes	Ramp Slope RT (%)	5.5
No	Ramp XSlope LT (%)	6.3	Yes	Ramp XSlope RT (%)	0.0
N/A	Ramp Length (in)	25.0	No	Ramp Slope (%)	9.6
Yes	Ramp Width (in)	48.0	No	Ramp XSlope (%)	3.0
N/A	Flare Type LT	N/A	N/A	Flare Type RT	N/A
N/A	Flare Slope LT (%)	N/A	N/A	Flare Slope RT (%)	N/A
N/A	Flare Traversable LT?	N/A	N/A	Flare Traversable RT?	N/A
N/A	Landing Length (in)	N/A	N/A	DWS Provided?	N/A
N/A	Landing Width (in)	N/A	N/A	DWS Contrast?	N/A
N/A	Landing Slope (%)	N/A	N/A	DWS Length (in)	N/A
N/A	Landing X Slope (%)	N/A	N/A	DWS Full Width?	N/A
N/A	Landing Curb? (Y/N)	N/A	N/A	DWS Offset (in)	N/A
N/A	Shared Landing?	N/A			
N/A	Gutter Ponding?	N/A	N/A	Gutter Slope (%)	N/A
N/A	Gutter Lip Ht (in)	N/A	N/A	Gutter X Slope (%)	N/A
N/A	Painted X Walk1?	No	N/A	Painted X Walk2?	No

Possible Solutions:
Remove & Replace Curb Ramp With Two New Directional Ramps or Equivalent.
