# Access Compliance Report

## Public Rights-of-Way

| Intersection ID: 24279 | Main Street: EDENBRIDGE_LN | Cross Street: WINDYRUSH_RD | Location: S |
| ADA ID: D5F3EA071AA0 | Ramp Type: PerpDiag | Initial Pass/Fail: Fail | Overall Compliance: No |

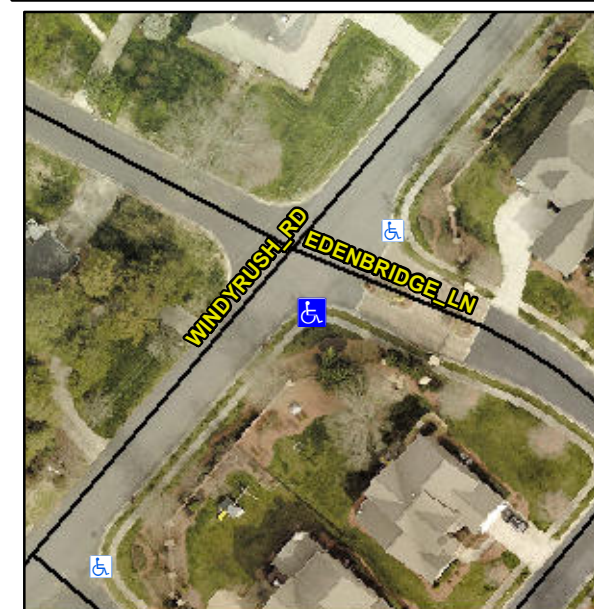
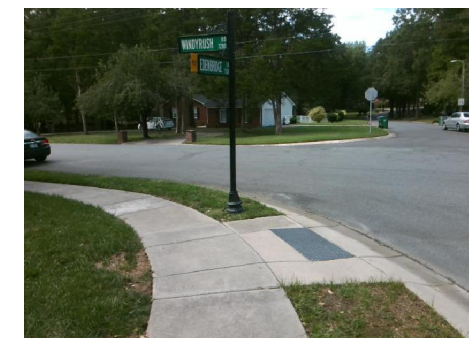
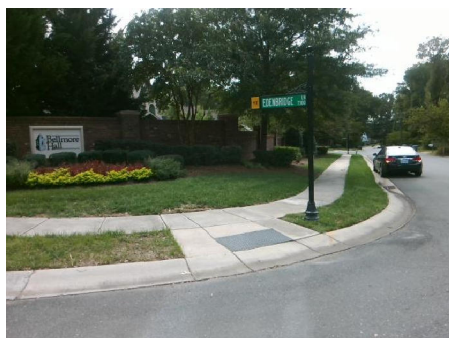
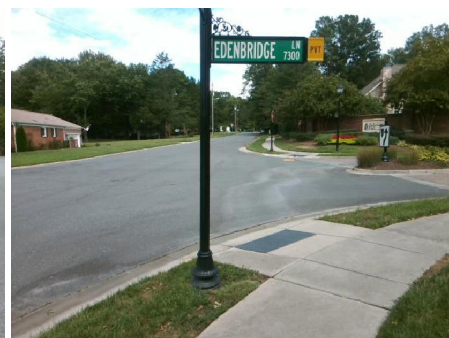
| Severity Score: 22.5 | | | |

**Not Found, R304.5.1, R304.2.2, R304.5.3**

| Compliance | Description | Data | Compliance | Description | Data |
|---|---|---|---|---|---|
| N/A | Ramp Length (in) | 44.0 | No | Ramp Slope (%) | 9.9 |
| No | Ramp Width (in) | 42.0 | No | Ramp XSlope (%) | 4.9 |

**Remove & Replace Curb Ramp With Two New Directional Ramps or Equivalent.**

Total Cost: \$ 3200.00
