# Access Compliance Report

## Public Rights-of-Way

### (Curb Ramps)

| Intersection ID: 10030604 | Main Street: LOMA_LINDA_LN | Cross Street: N/A | Location: E |

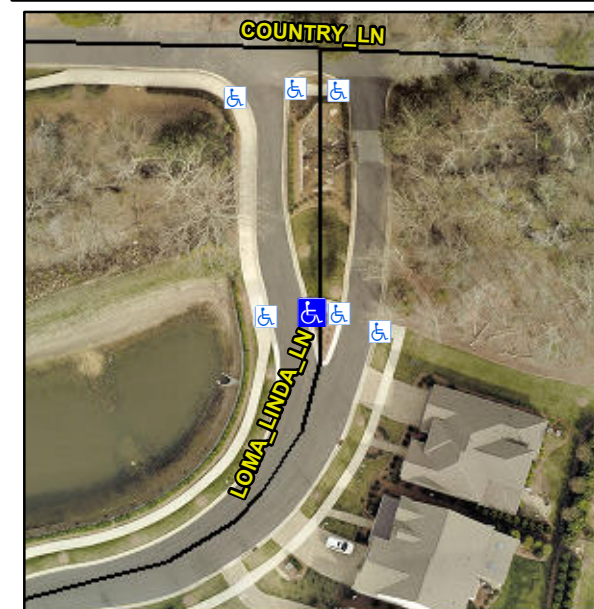
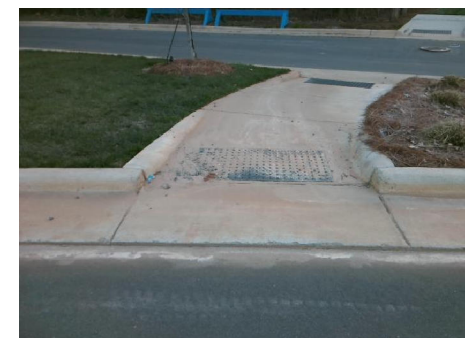
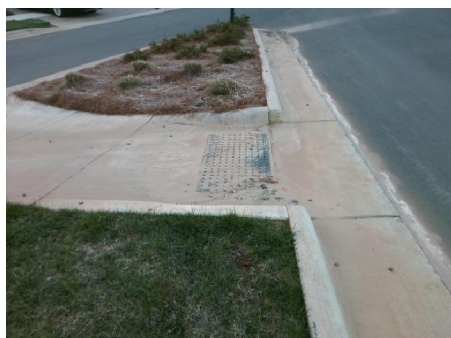
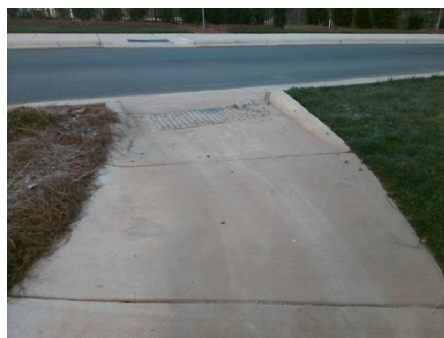
**Not Found, R304.2.2-Perp, R304.3.2-Para, R305.1.4, R304.5.4**

| Compliance | Description | Data | Compliance | Description | Data |
|---|---|---|---|---|---|
| No | Landing Slope (%) | 11.1 | Yes | DWS Length (in) | 24.0 |
| Yes | Landing X Slope (%) | 2.8 | No | DWS Full Width? | No |
| Yes | Gutter Ponding? | No | No | Gutter Slope (%) | 5.8 |
| | | | No | Curb Slope (%) | 8.7 |

**Remove & Replace Curb Ramp With Two New Directional Ramps or Equivalent. Remove & Replace Gutter.**
