Access Compliance Report Public Rights-of-Way (Curb Ramps)

Intersection ID: 20718 Main Street: PROVIDENCE_RD Cross Street: EAST_BARDEN_RD Location: N

ADA ID: D67A208D34B9 Ramp Type: Perp Initial Pass/Fail: Fail Overall Compliance: No Severity Score: 13.75

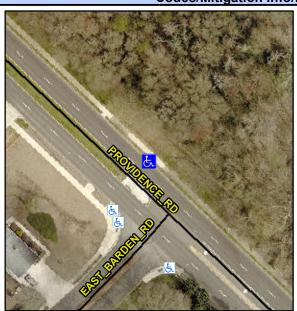
Not Found, R304.2.2, R304.5.3

ried Measurements/Component Compliance					
Compliance Description		Data	Compliance Description		Data
N/A	Ramp Length (in)	33.0	No	Ramp Slope (%)	9.0
Yes	Ramp Width (in)	64.0	No	Ramp XSlope (%)	3.2
N/A	Flare Type LT	N/A	N/A	Flare Type RT	N/A
N/A	Flare Slope LT (%)	N/A	N/A	Flare Slope RT (%)	N/A
N/A	Flare Traversable LT?	N/A	N/A	Flare Traversable RT?	N/A
N/A	Landing Length (in)	N/A	N/A	DWS Provided?	N/A
N/A	Landing Width (in)	N/A	N/A	DWS Contrast?	N/A
N/A	Landing Slope (%)	N/A	N/A	DWS Length (in)	N/A
N/A	Landing X Slope (%)	N/A	N/A	DWS Full Width?	N/A
N/A	Landing Curb? (Y/N)	N/A	N/A	DWS Offset (in)	N/A
N/A	Shared Landing?	N/A			
N/A	Gutter Ponding?	N/A	N/A	Gutter Slope (%)	N/A
N/A	Gutter Lip Ht (in)	N/A	N/A	Gutter X Slope (%)	N/A
N/A	Painted X Walk1?	No	N/A	Painted X Walk2?	N/A
	X Walk 1 Direction	To SW		X Walk 2 Direction	N/A
N/A	X Walk 1 Width (in)	N/A	N/A	X Walk 2 Width (in)	N/A
	X Walk 1 Slope (%)	3.8		X Walk 2 Slope (%)	N/A

Remove & Replace Entire Ramp.
