# Access Compliance Report

## Public Rights-of-Way

### (Curb Ramps)

| Intersection ID: 10541 | Main Street: CANTON_PL | Cross Street: POLK_ST | Location: SW |

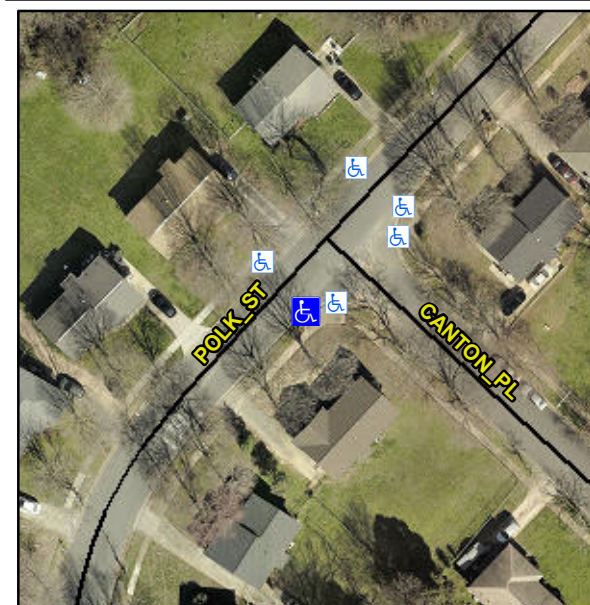
**LT RP < 5%**

**Not Found, R304.5.1, R304.5.3,  
R304.3.2**

**Remove & Replace Entire Ramp.  
Remove & Replace Sidewalk.**
