Access Compliance Report Public Rights-of-Way (Curb Ramps)

Intersection ID: N/A Main Street: PROVIDENCE_COUNTRY_CLUBE_ross Street: MCGILL_HEIGHTS_RD Location: NW **Severity Score: Overall Compliance: No** ADA ID: D791D941A17A Ramp Type: Perp Initial Pass/Fail: Fail 12.5

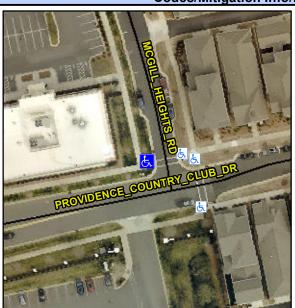
| i cccibic cciation | |
|---|---|
| Not Found, R304.2.2 | N |

| Field Measurements/Component Compliance | | | | | | | | |
|---|---|---|---|---|---|--|--|--|
| N/A | Ramp Length (in) | 84.0 | No | Ramp Slope (%) | 9.8 | | | |

| i cccibic cciation | |
|---|---|
| Remove & Replace Entire Ramp. | |
