Access Compliance Report

Public Rights-of-Way

| Intersection ID: 50605 | Main Street: DENBUR_DR | Cross Street: RHODORA_RD | Location: S |
| ADA ID: D7A4631EFB65 | Ramp Type: Perp | Initial Pass/Fail: Fail | Overall Compliance: No |

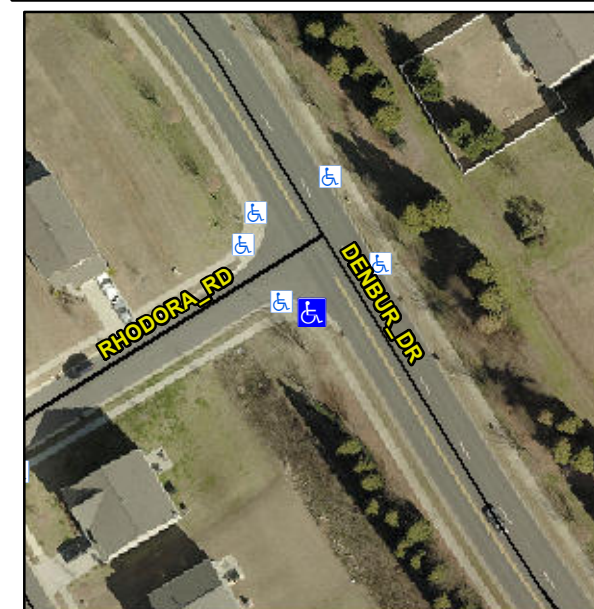
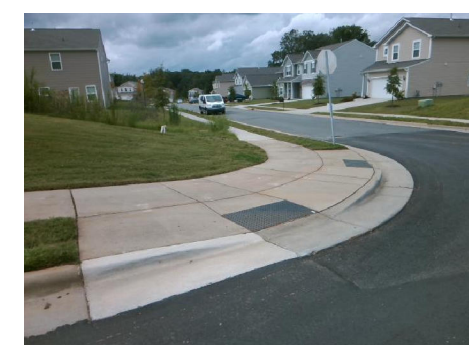
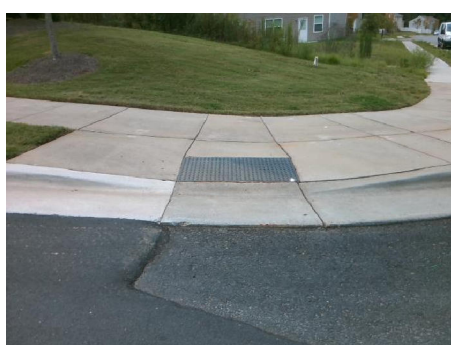
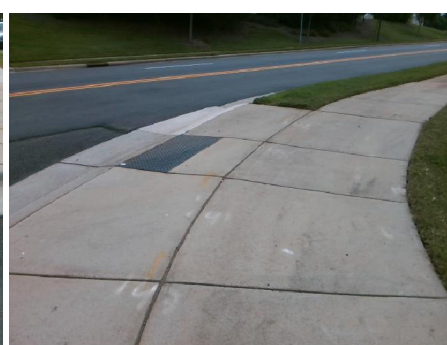
| Severity Score: 33.75 | | | |

Not Found, R304.5.1, R304.5.3

| Compliance | Description | Data | Compliance | Description | Data |
|---|---|---|---|---|---|
| No | Ramp Width (in) | 41.5 | No | Ramp XSlope (%) | 7.1 |

Remove & Replace Entire Ramp.
