Access Compliance Report

Public Rights-of-Way

(Curb Ramps)

| Intersection ID: 4935 | Main Street: OLD_STATESVILLE_RD | Cross Street: HENDERSON_CR | Location: S |

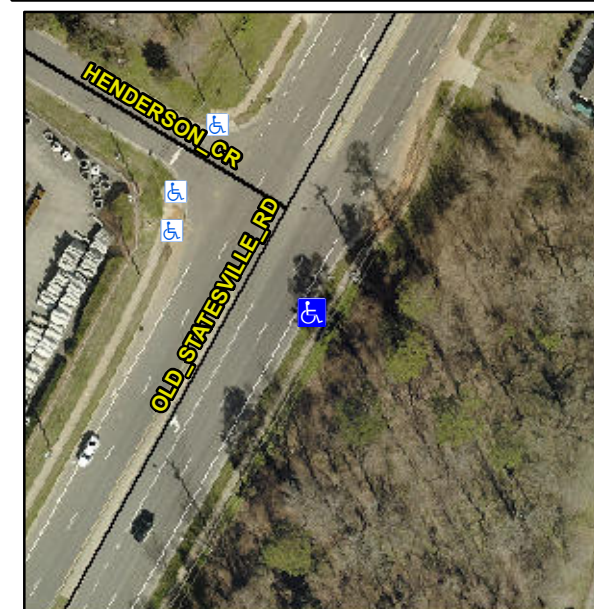
R304.5.1, R304.2.2

| Compliance | Description | Data | Compliance | Description | Data |
|---|---|---|---|---|---|
| N/A | Ramp Length (in) | 63.0 | No | Ramp Slope (%) | 9.5 |
| No | Ramp Width (in) | 46.5 | Yes | Ramp XSlope (%) | 1.0 |

Remove & Replace Entire Ramp.
