Access Compliance Report

Public Rights-of-Way

(Curb Ramps)

Intersection ID: 10011755	Main Street: DAWN_CR	Cross Street: N/A	Location: E
ADA ID: D8190E7C6B13	Ramp Type: Combination2	Initial Pass/Fail: Fail	Overall Compliance: No
		Severity Score: 12.5

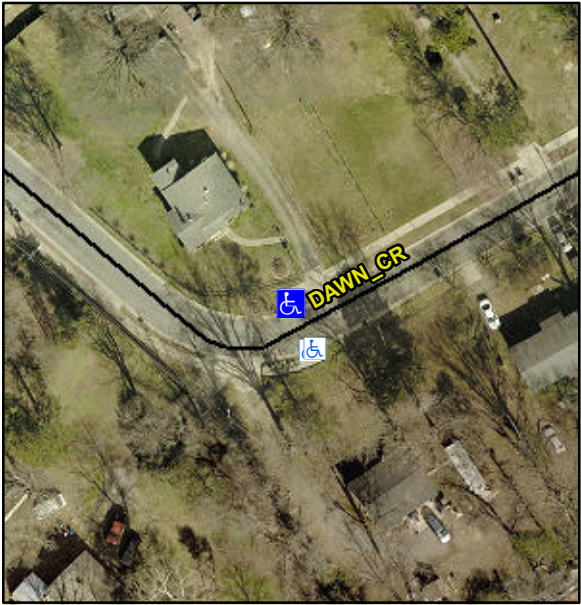
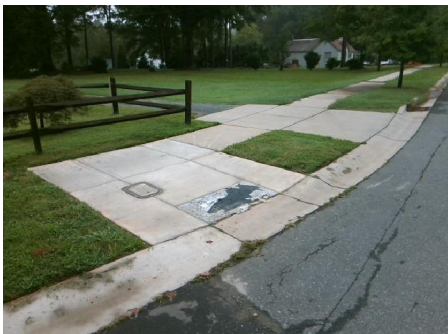
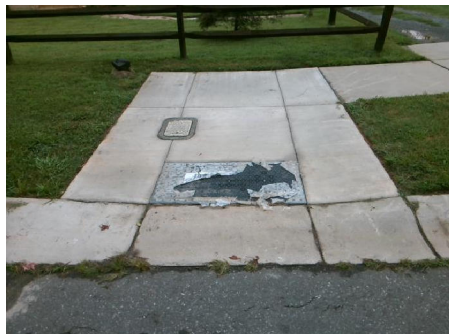
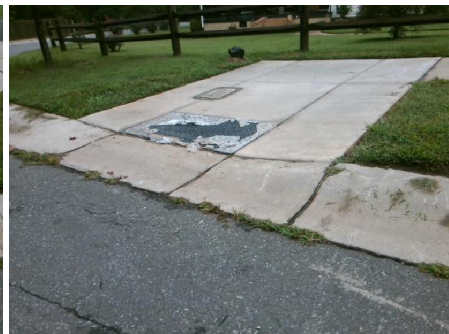
DAMAGED DWS, LT RP < 5%

Not Found, R304.5.3

Remove & Replace Entire Ramp.
