# Access Compliance Report

## Public Rights-of-Way

### (Curb Ramps)

Intersection ID: 53270	Main Street: MONROE_RD	Cross Street: MERIDIAN_CENTER_DR	Location: SE
ADA ID: D81A347A1BEB	Ramp Type: Para	Initial Pass/Fail: Fail	Overall Compliance: No
Codes/Mitigation Info/Possible Solution		Field Measurements/Component Compliance	
Severity Score: 12.5

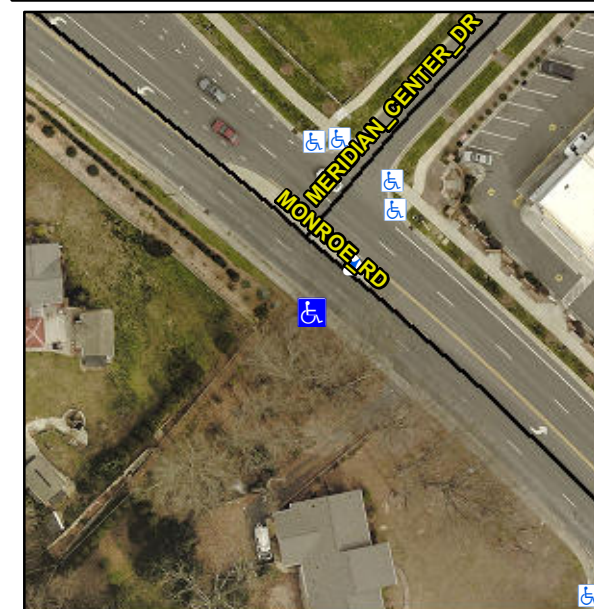
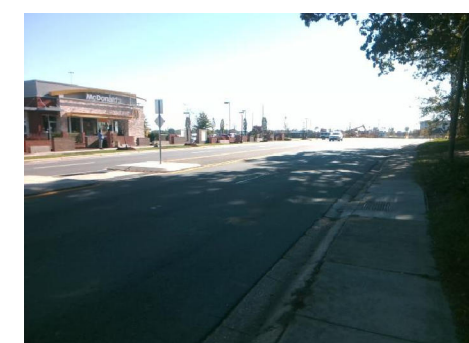
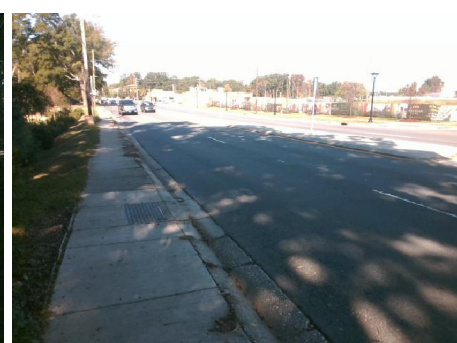
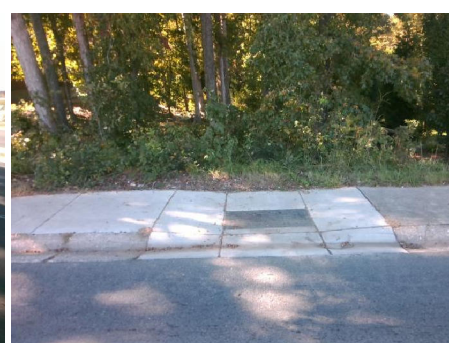
**R304.3.2**

Compliance	Description	Data	Compliance	Description	Data
N/A	Ramp Length LT (in)	36.0	N/A	Ramp Length RT (in)	36.0
Yes	Ramp Width LT (in)	60.0	Yes	Ramp Width RT (in)	60.0
No	Ramp Slope LT (%)	9.0	Yes	Ramp Slope RT (%)	5.0
Yes	Ramp XSlope LT (%)	1.8	Yes	Ramp XSlope RT (%)	0.8
N/A	Landing Length (in)	N/A	N/A	DWS Provided?	N/A
N/A	Landing Width (in)	N/A	N/A	DWS Contrast?	N/A
N/A	Landing Slope (%)	N/A	N/A	DWS Length (in)	N/A
N/A	Landing X Slope (%)	N/A	N/A	DWS Full Width?	N/A
N/A	Landing Curb? (Y/N)	N/A	N/A	DWS Offset (in)	N/A
N/A	Shared Landing?	N/A			
N/A	Gutter Ponding?	N/A	N/A	Gutter Slope (%)	N/A
N/A	Gutter Lip Ht (in)	N/A	N/A	Gutter X Slope (%)	N/A
N/A	Painted X Walk1?	No	N/A	Painted X Walk2?	N/A
	X Walk 1 Direction	To NE		X Walk 2 Direction	N/A
N/A	X Walk 1 Width (in)	N/A	N/A	X Walk 2 Width (in)	N/A
	X Walk 1 Slope (%)	7.0		X Walk 2 Slope (%)	N/A
	X Walk 1 X Slope (%)	1.9		X Walk 2 X Slope (%)	N/A
N/A	Ramp inside XWalk1?	N/A	N/A	Ramp inside XWalk2?	N/A

**Remove & Replace Entire Ramp.**
