## Access Compliance Report Public Rights-of-Way (Curb Ramps)

Intersection ID: 29975 Main Street: DAVID\_COX\_RD Cross Street: LEGACY\_LAKE\_LN Location: NE

ADA ID: D84A8DE2516C Ramp Type: Perp Initial Pass/Fail: Fail Overall Compliance: No Severity Score: 8.75

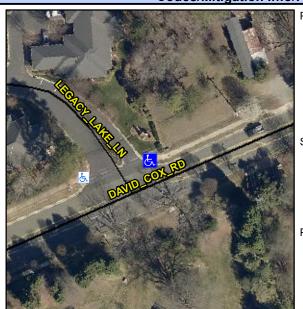
Not Found, R304.5.1

| Field Measurements/Component Compliance | | | | | |
|---|---|---|---|---|---|
| No | Ramp Width (in) | 47.5 | Yes | Ramp XSlope (%) | 1.4 |

Remove & Replace Entire Ramp.
