Access Compliance Report

Public Rights-of-Way

(Curb Ramps)

Intersection ID: 10780	Main Street: GESCO_ST	Cross Street: STATE_ST	Location: W
ADA ID: D85041BE7339	Ramp Type: Perp	Initial Pass/Fail: Fail	Overall Compliance: No
		Severity Score: 22.5

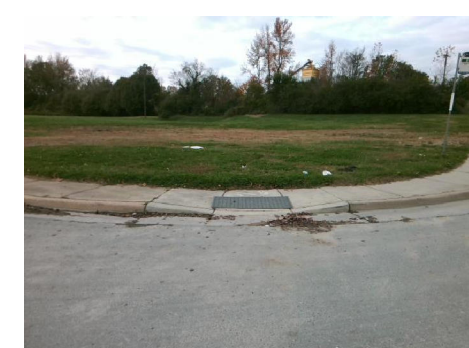
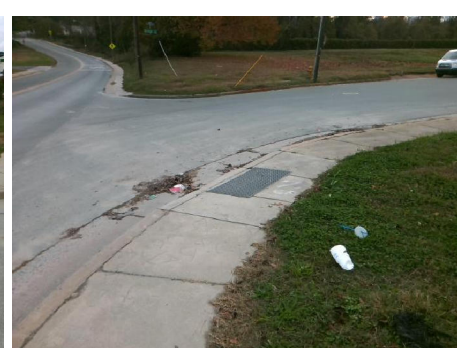
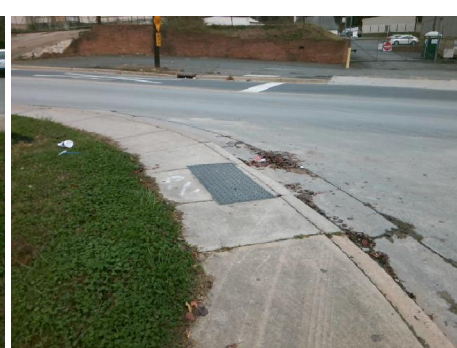
Possible Solutions:		Compliance	Description	Data	Compliance
	Remove & Replace Entire Ramp.		No	Ramp Length (in)	53.0	No
			No	Ramp Width (in)	36.0	No
			N/A	Flare Type LT	N/A	N/A
			N/A	Flare Slope LT (%)	N/A	N/A
			N/A	Flare Traversable LT?	N/A	N/A
			N/A	Landing Length (in)	N/A	N/A
			N/A	Landing Width (in)	N/A	N/A
			N/A	Landing Slope (%)	N/A	N/A
			N/A	Landing X Slope (%)	N/A	N/A
<p>Surveyor Notes:</p> <p>N/A</p> <p>PROW/ADA:</p> <p>Not Found, R304.5.1, R304.2.2, R304.5.3</p>			N/A	Flare Type RT	N/A	N/A
			N/A	Flare Slope RT (%)	N/A	N/A
			N/A	Flare Traversable RT?	N/A	N/A
			N/A	DWS Provided?	N/A	N/A
			N/A	DWS Contrast?	N/A	N/A
			N/A	DWS Length (in)	N/A	N/A
			N/A	DWS Full Width?	N/A	N/A
			N/A	DWS Offset (in)	N/A	N/A
			N/A	Gutter Ponding?	Yes	N/A
			N/A	Gutter Lip Ht (in)	N/A	N/A
<p>Total Cost:</p> <p>\$ 1850.00</p>			No	Painted X Walk1?	No	N/A
