Access Compliance Report Public Rights-of-Way (Curb Ramps)

Intersection ID: 4893 Main Street: BAUCOM RD Cross Street: HARRINGTON_WOODS_RD Location: SW ADA ID: D92621A27358 Ramp Type: Perp Initial Pass/Fail: Fail **Overall Compliance: No** Severity Score: 21.25

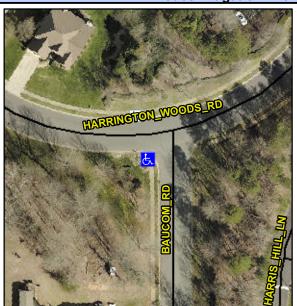
Comp	liance Description	Data	Comp	liance Description	Data
N/A	Ramp Length (in)	48.0	No	Ramp Slope (%)	10.
No	Ramp Width (in)	45.0	Yes	Ramp XSlope (%)	1.3
N/A	Flare Type LT	N/A	N/A	Flare Type RT	N/A
N/A	Flare Slope LT (%)	N/A	N/A	Flare Slope RT (%)	N/A
N/A	Flare Traversable LT?	N/A	N/A	Flare Traversable RT?	N/A
N/A	Landing Length (in)	N/A	N/A	DWS Provided?	N/A
N/A	Landing Width (in)	N/A	N/A	DWS Contrast?	N/A
N/A	Landing Slope (%)	N/A	N/A	DWS Length (in)	N/A
N/A	Landing X Slope (%)	N/A	N/A	DWS Full Width?	N/A
N/A	Landing Curb? (Y/N)	N/A	N/A	DWS Offset (in)	N/A
N/A	Shared Landing?	N/A			
N/A	Gutter Ponding?	N/A	N/A	Gutter Slope (%)	N/A
N/A	Gutter Lip Ht (in)	N/A	N/A	Gutter X Slope (%)	N/A
N/A	Painted X Walk1?	No	N/A	Painted X Walk2?	N/A
	X Walk 1 Direction	To N		X Walk 2 Direction	N/A
N/A	X Walk 1 Width (in)	N/A	N/A	X Walk 2 Width (in)	N/A
	X Walk 1 Slope (%)	0.2		X Walk 2 Slope (%)	N/A
	X Walk 1 X Slope (%)	0.6		X Walk 2 X Slope (%)	N/A

Possible Solutions:
Remove & Replace Entire Ramp.
Surveyor Notes:
N/A
PROW/ADA:
Not Found, R304.5.1, R304.2.2
