Access Compliance Report

Public Rights-of-Way

(Curb Ramps)

Intersection ID: 10023460	Main Street: CINDY_LN	Cross Street: N/A	Location: E
ADA ID: D95EDB9C0284	Ramp Type: Perp	Initial Pass/Fail: Fail	Overall Compliance: No
			Severity Score: 21.25

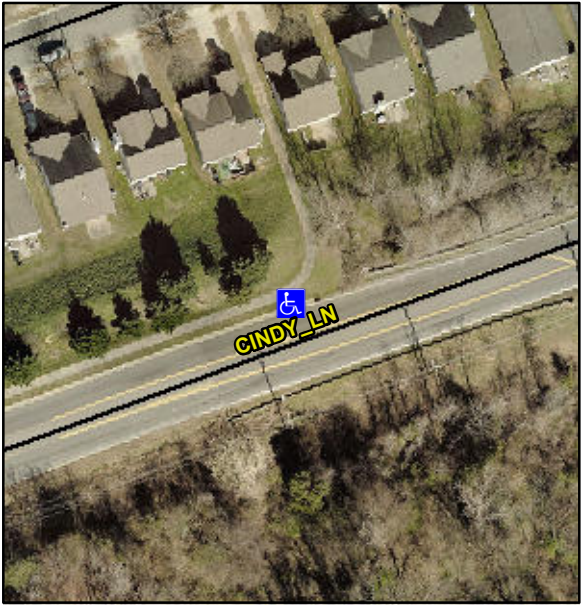
Possible Solutions:		Compliance	Description	Data
	Remove & Replace Entire Ramp.		N/A	Ramp Length (in)	57.0
			No	Ramp Width (in)	47.5
			N/A	Flare Type LT	N/A
			N/A	Flare Slope LT (%)	N/A
			N/A	Flare Traversable LT?	N/A
			N/A	Landing Length (in)	N/A
			N/A	Landing Width (in)	N/A
			N/A	Landing Slope (%)	N/A
			N/A	Landing X Slope (%)	N/A
<p>Surveyor Notes:</p> <p>N/A</p> <p>PROW/ADA:</p> <p>Not Found, R304.5.1, R304.5.3</p>			N/A	Flare Type RT	N/A
			N/A	Flare Slope RT (%)	N/A
			N/A	Flare Traversable RT?	N/A
			N/A	DWS Provided?	N/A
			N/A	DWS Contrast?	N/A
			N/A	DWS Length (in)	N/A
			N/A	DWS Full Width?	N/A
			N/A	DWS Offset (in)	N/A
			N/A	Shared Landing?	N/A
			N/A	Gutter Ponding?	N/A
			N/A	Gutter Lip Ht (in)	N/A
			N/A	Painted X Walk1?	No
				X Walk 1 Direction	To S
			N/A	X Walk 1 Width (in)	N/A
				X Walk 1 Slope (%)	7.4

X Walk 1 X Slope (%)	5.5
			N/A	Ramp inside XWalk1?	N/A
				Road Slope (%)	5.5
				Road X Slope (%)	7.4
			N/A	Any Obstructions?	N/A
				Obstruction Type	
			N/A		N/A
			Yes	Surface Condition? (G/P)	Good
