## **Access Compliance Report Public Rights-of-Way** (Curb Ramps)

Intersection ID: 14959 Main Street: EASTLAND MALL DR **Cross Street: CENTRAL AV** Location: Ε Initial Pass/Fail: Fail **Overall Compliance: No** 25 ADA ID: D9A787E1ADCC Ramp Type: Combination1 **Severity Score:**

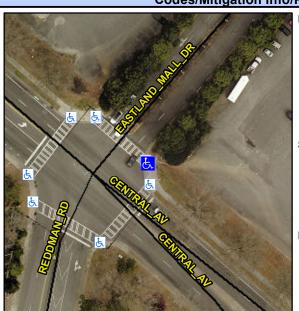
Possible Solutions: Compliance Description N/A Remove & Replace Entire Ramp. Yes Yes Yes N/A Yes Surveyor Notes: N/A N/A N/A N/A N/A N/A PROW/ADA: N/A Not Found, R304.2.2, R304.5.3 N/A N/A N/A N/A N/A N/A
