# Access Compliance Report

## Public Rights-of-Way

### (Curb Ramps)

Intersection ID: 48448	Main Street: DUSTY_SADDLE_RD	Cross Street: BURNT_LEATHER_LN	Location: E
ADA ID: DA57E8137B3F	Ramp Type: BlendTrans1	Initial Pass/Fail: Fail	Overall Compliance: No
Severity Score: 12.5			
Codes/Mitigation Info/Possible Solution		Field Measurements/Component Compliance

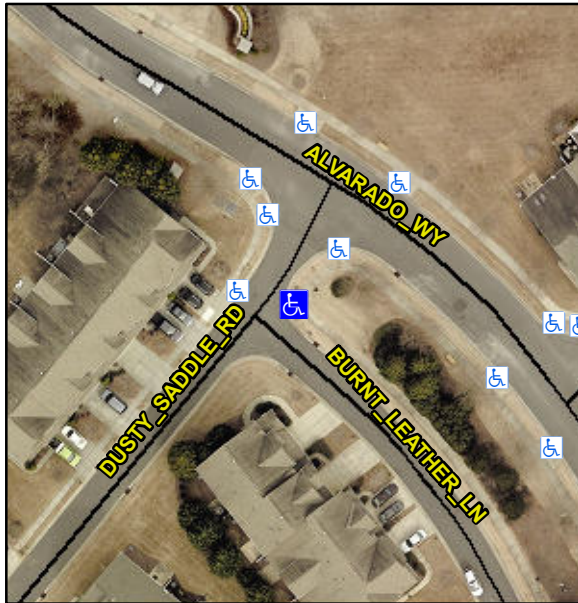
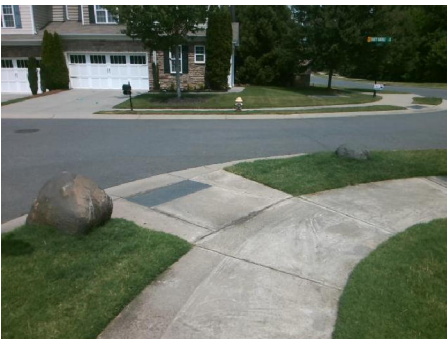
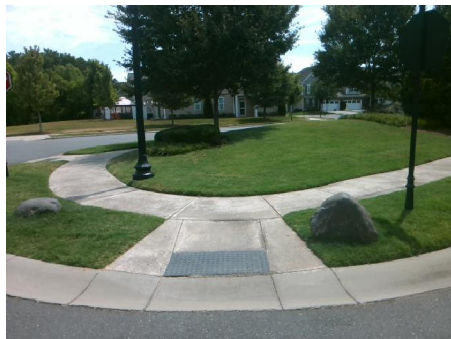
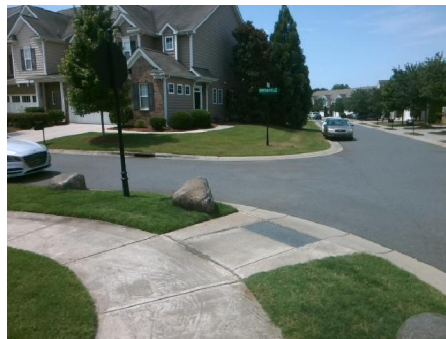
**Not Found, R304.5.3**

Compliance	Description	Data	Compliance	Description	Data
N/A	Ramp Length (in)	71.0	Yes	BlendTrans Slope (%)	4.9
Yes	Ramp Width (in)	48.0	No	BlendTrans XSlope (%)	5.1
N/A	Flare Type LT	N/A	N/A	Flare Type RT	N/A
N/A	Flare Slope LT (%)	N/A	N/A	Flare Slope RT (%)	N/A
N/A	Flare Traversable LT?	N/A	N/A	Flare Traversable RT?	N/A
N/A	Landing Length (in)	N/A	N/A	DWS Provided?	N/A
N/A	Landing Width (in)	N/A	N/A	DWS Contrast?	N/A
N/A	Landing Slope (%)	N/A	N/A	DWS Length (in)	N/A
N/A	Landing X Slope (%)	N/A	N/A	DWS Full Width?	N/A
N/A	Landing Curb? (Y/N)	N/A	N/A	DWS Offset (in)	N/A
N/A	Shared Landing?	N/A			
N/A	Gutter Ponding?	N/A	N/A	Gutter Slope (%)	N/A
N/A	Gutter Lip Ht (in)	N/A	N/A	Gutter X Slope (%)	N/A
N/A	Painted X Walk1?	No	N/A	Painted X Walk2?	No
	X Walk 1 Direction	To NW		X Walk 2 Direction	To SW
	X Walk 1 Width (in)	N/A		X Walk 2 Width (in)	N/A
	X Walk 1 Slope (%)	2.0		X Walk 2 Slope (%)	0.7
	X Walk 1 X Slope (%)	0.5		X Walk 2 X Slope (%)	0.6

N/A	Ramp inside XWalk1?	N/A	N/A	Ramp inside XWalk2?	N/A
	Road Slope (%)	0.7		Clear Space?	N/A
	Road X Slope (%)	1.0	N/A	Clear Space to XWalk (in)	N/A
N/A	Any Obstructions?	N/A	N/A	Storm Grate/Utility Hazard?	N/A
	Obstruction Type			Storm Grate/Utility Type	
		N/A			N/A
			Yes	Surface Condition? (G/P)	Good
			No	Curb Slope (%)	8.4

**Remove & Replace Curb Ramp With Two New Directional Ramps or Equivalent.**
