# Access Compliance Report

## Public Rights-of-Way

| Intersection ID: 50664 | Main Street: CRAIGHILL_LN | Cross Street: WITHERS_RD | Location: NE |
| ADA ID: DA6DF5E618A6 | Ramp Type: PerpDiag | Initial Pass/Fail: Fail | Overall Compliance: No |

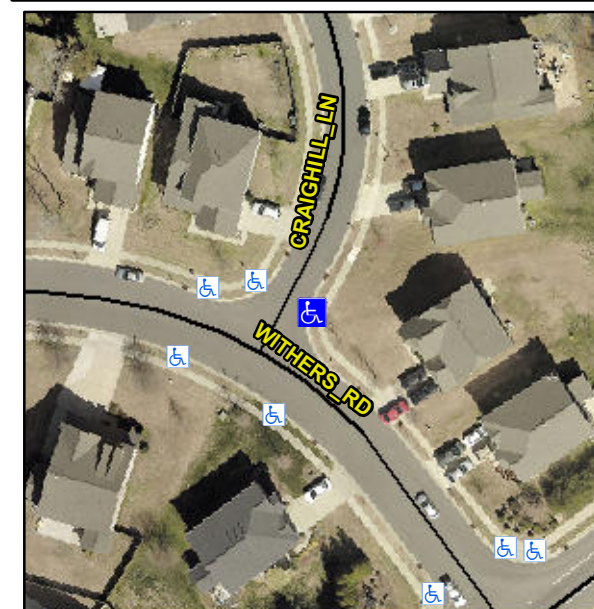
**R304.2.2, R304.5.3**

| Compliance | Description | Data | Compliance | Description | Data |
|---|---|---|---|---|---|
| N/A | Ramp Length (in) | 48.0 | No | Ramp Slope (%) | 8.9 |
| Yes | Ramp Width (in) | 48.0 | No | Ramp XSlope (%) | 6.7 |

**Remove & Replace Curb Ramp With Two New Directional Ramps or Equivalent.**
