Access Compliance Report Public Rights-of-Way (Curb Ramps)

Intersection ID: 13708 Main Street: WEST BV Cross Street: WICKFORD_PL Location: NE ADA ID: DAA1585C1A01 Ramp Type: Perp Initial Pass/Fail: Fail **Overall Compliance: No Severity Score:** 1.25

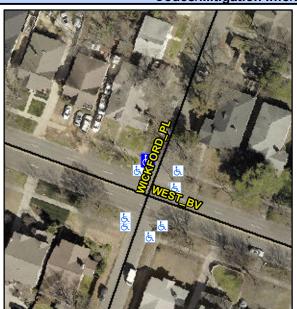
Field Measurements/Component Compliance							
Comp	liance Description	Data	Comp	liance Description	Data		
N/A	Ramp Length (in)	65.0	Yes	Ramp Slope (%)	5.5		
Yes	Ramp Width (in)	61.0	No	Ramp XSlope (%)	4.0		
N/A	Flare Type LT	N/A	N/A	Flare Type RT	N/A		
N/A	Flare Slope LT (%)	N/A	N/A	Flare Slope RT (%)	N/A		
N/A	Flare Traversable LT?	N/A	N/A	Flare Traversable RT?	N/A		
N/A	Landing Length (in)	N/A	N/A	DWS Provided?	N/A		
N/A	Landing Width (in)	N/A	N/A	DWS Contrast?	N/A		
N/A	Landing Slope (%)	N/A	N/A	DWS Length (in)	N/A		
N/A	Landing X Slope (%)	N/A	N/A	DWS Full Width?	N/A		
N/A	Landing Curb? (Y/N)	N/A	N/A	DWS Offset (in)	N/A		
N/A	Shared Landing?	N/A					
N/A	Gutter Ponding?	Yes	N/A	Gutter Slope (%)	N/A		
N/A	Gutter Lip Ht (in)	2.0	N/A	Gutter X Slope (%)	N/A		
N/A	Painted X Walk1?	No	N/A	Painted X Walk2?	N/A		
	X Walk 1 Direction	To SE		X Walk 2 Direction	N/A		
N/A	X Walk 1 Width (in)	N/A	N/A	X Walk 2 Width (in)	N/A

X Walk 1 Slope (%)	4.0		X Walk 2 Slope (%)	N/A		
	X Walk 1 X Slope (%)	0.0		X Walk 2 X Slope (%)	N/A		
N/A	Ramp inside XWalk1?	N/A	N/A	Ramp inside XWalk2?	N/A		
	Road Slope (%)	N/A	N/A	Clear Space?	N/A		
	Road X Slope (%)	N/A	N/A	Clear Space to XWalk (in)	N/A		
N/A	Any Obstructions?	N/A	N/A	Storm Grate/Utility Hazard?	N/A		
	Obstruction Type			Storm Grate/Utility Type			
		N/A			N/A		
			Yes	Surface Condition? (G/P)	Good

Possible Solutions:	Cor
Remove & Replace Entire Ramp.	N/A
	Yes
	N/A
	N/A
	N/A
	N/A
Surveyor Notes:	N/A
N/A	N/A
	N/A
	N/A
	N/A
PROW/ADA:	N/A
Not Found, R304.5.3	N/A
	N/A
	N/A
	N/A
